# Inspection Report

## Westbrook Homes, LLC

Sample Report

123 Sample Cove

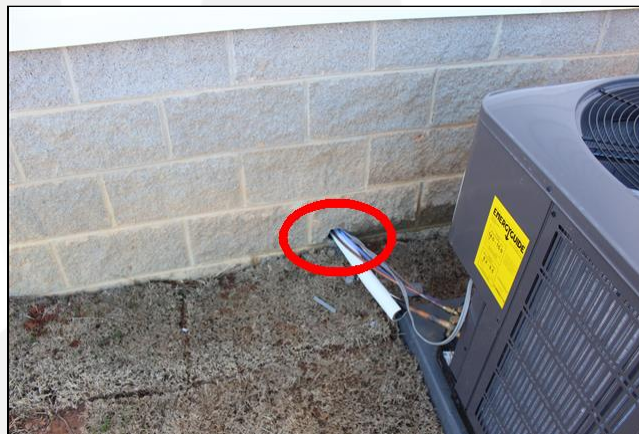
2.0 Item 1(Picture)

1. A waterproof sealant applied at the joint between the wall and the pipe/wire.
2. A flashing of an approved elastomeric material.

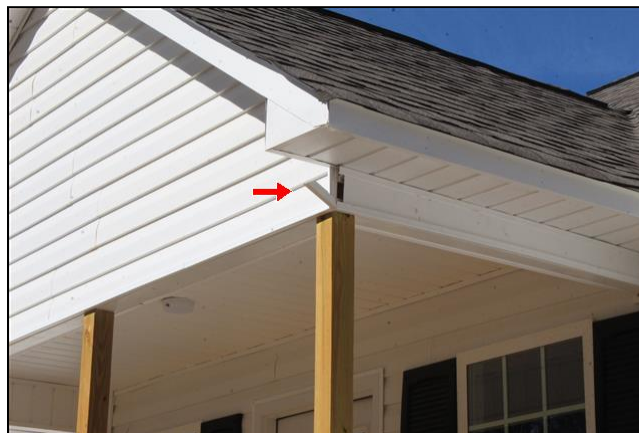
2.0 Item 2(Picture)

**2.0 (2)** Loose trim observed at the front porch simply needs to be resecured.

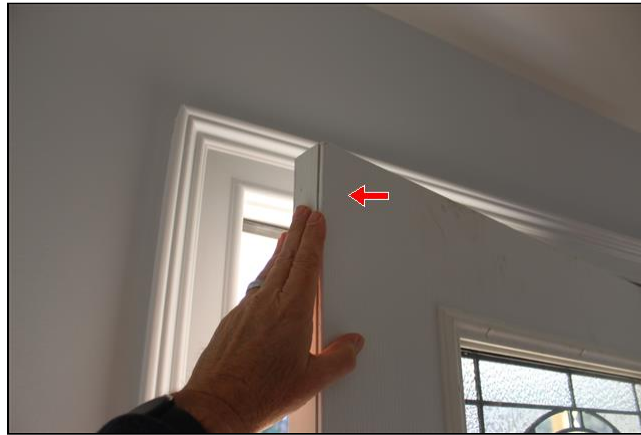
2.2 Item 1(Picture)

2.2 (1) Minor damage observed a the front entry door where the interior panel was observed to be cracked.

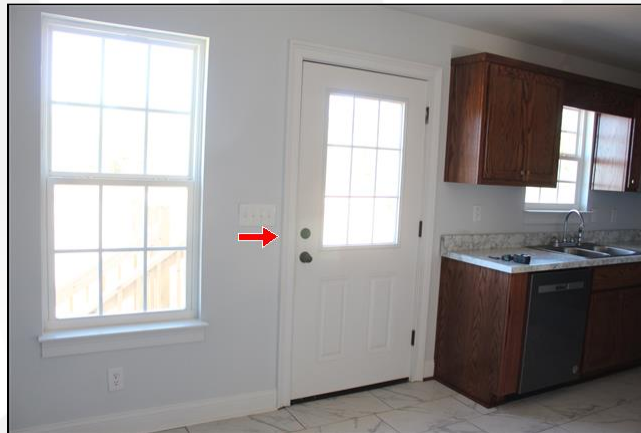
2.2 Item 2(Picture)

2.2 (2) The rear entry door needs dead bolt / strike plate adjustment to lock properly, bolt would not engage into the jam when the door was shut completely.

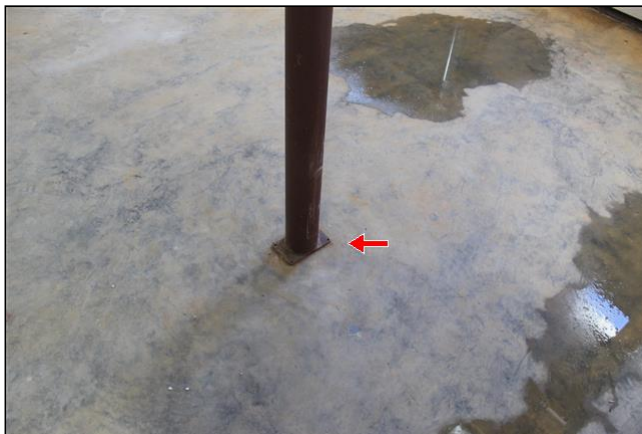
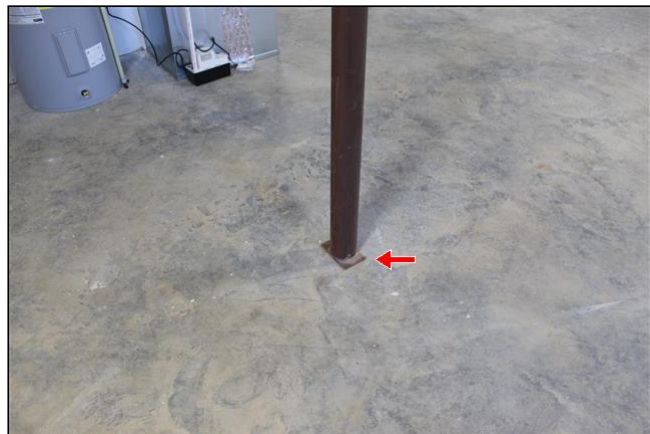
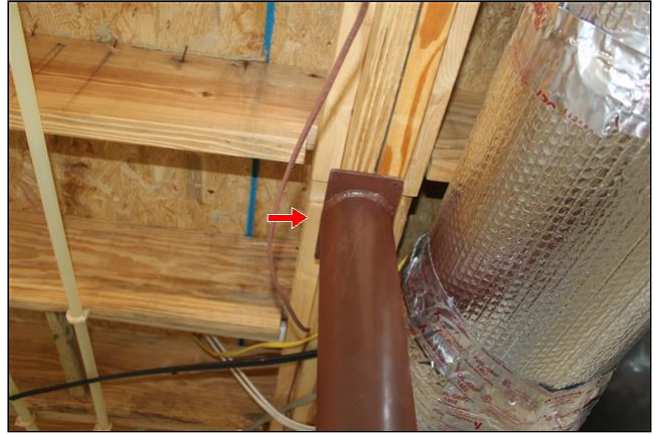
3.2 Item 1(Picture)

**3.2** The steel lally columns are missing anchors to secure support post to the slab in the garage. Anchors should be added as to secure these posts.

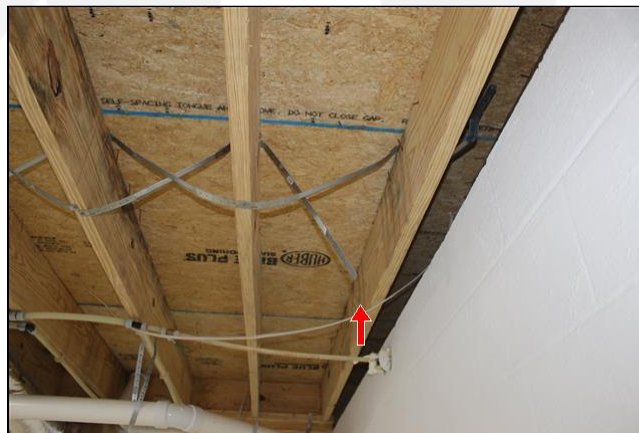
3.3 Item 1(Picture)

**3.3 (1)** Installation of the LTB (Light Tension Bridging) for bracing between the floor joists has not been completed. Installed in pairs, this light tension-type bridging keeps joists in place and prevents them from rotating while distributing loads over more than one joist. Installation should be completed.

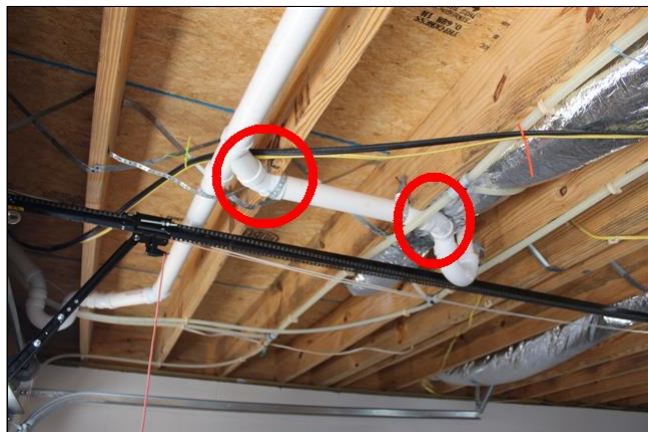
3.3 Item 2(Picture)

**3.3 (2)** Notches in solid lumber joists, rafters and beams shall not exceed one-sixth of the depth of the member, shall not be longer than one-third of the depth of the member and shall not be located in the middle one-third of the span. Observed several joists in which notches were made in the middle one-third of the span compromising these joists. Corrections are needed where the joists have been damaged.

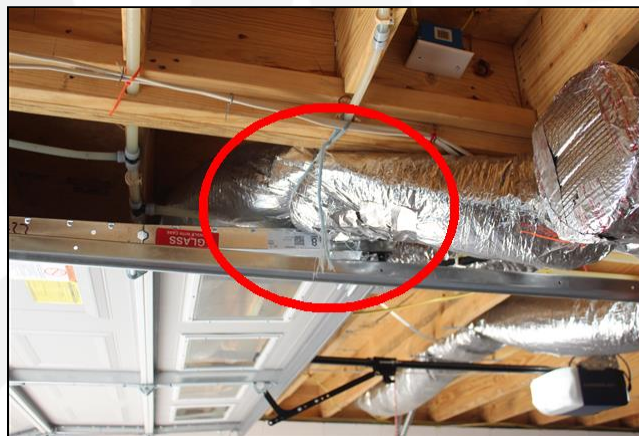
4.0 Item 3(Picture)

**4.0 (2)** The duct work was observed to coming in contact with the garage door operation which will damage the duct over time, the duct in this location should be relocated.

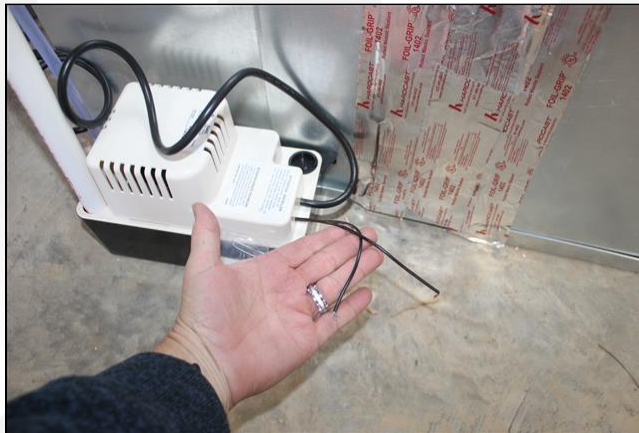
4.3 Item 2(Picture)

**4.3 (2)** The condensate pump installed should be wired into the system, this is a function of the condensate pump installed that will shut the unit down should the pump fail.

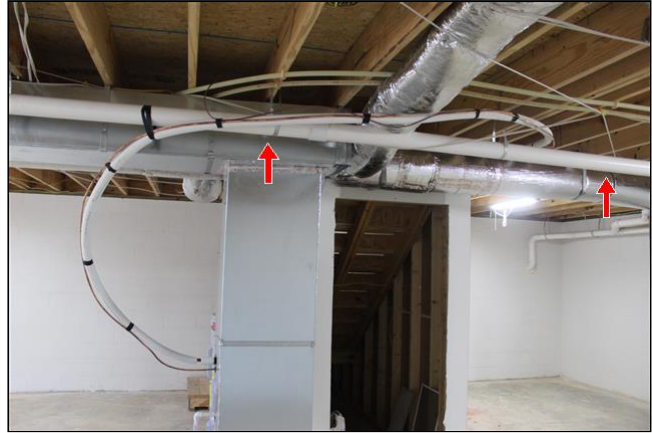
4.3 Item 4(Picture)

4.3 (4) Refrigerant Line support observed to be missing typically these lines should be supported every 6'. Poorly supported lines should be correctly supported.

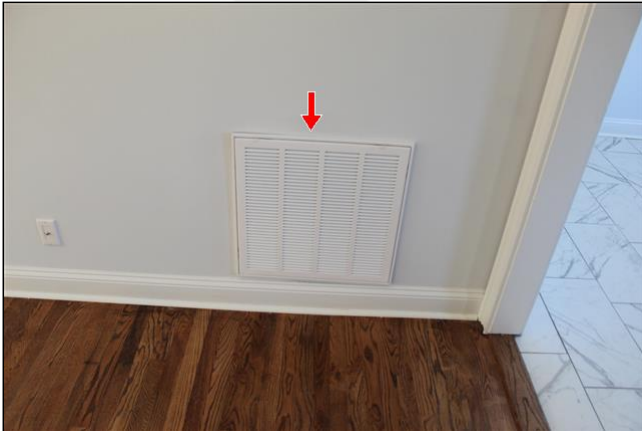
4.5 Item 1(Picture)

4.5 The filter change location is located in the living room wall. No filter installed at time of inspection.

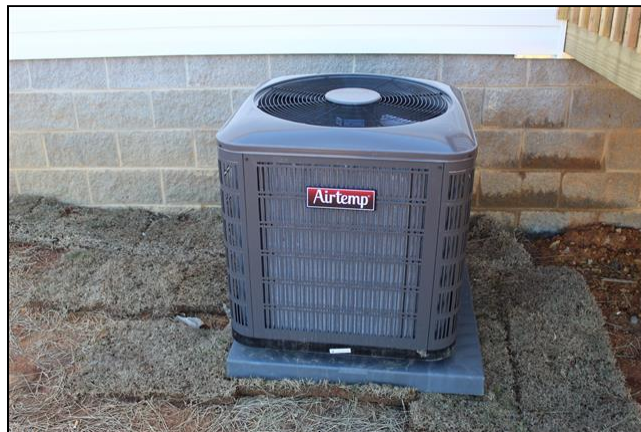
4.6 Item 1(Picture)

4.6 A 16 degree delta on the cooling system indicates the range in temperature drop is normal.

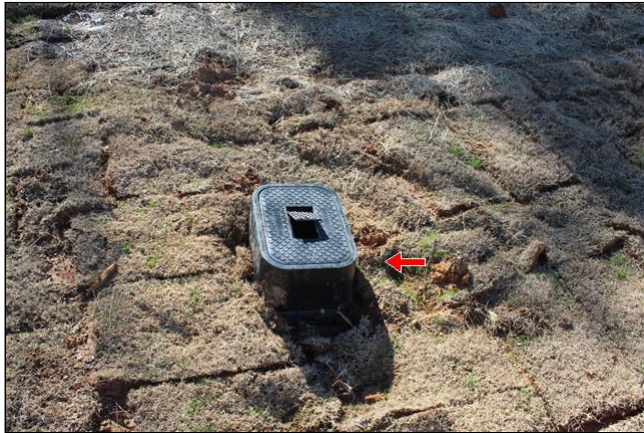
5.0 Item 1(Picture)

5.0 The main shut off is located outside in the ground at the water meter. Also there is a main shut off in the garage where the main water line enters the home.

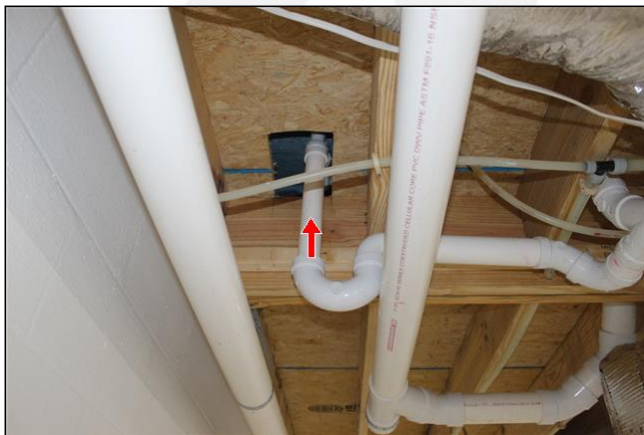
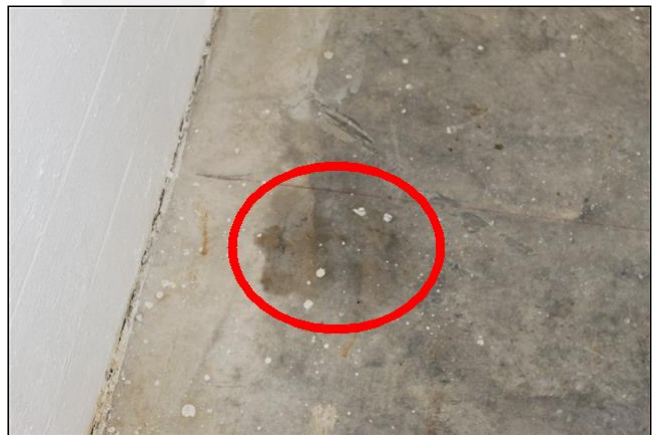
5.1 Item 1(Picture)

5.1 The Hall Bath bathtub leaks from the waste line.

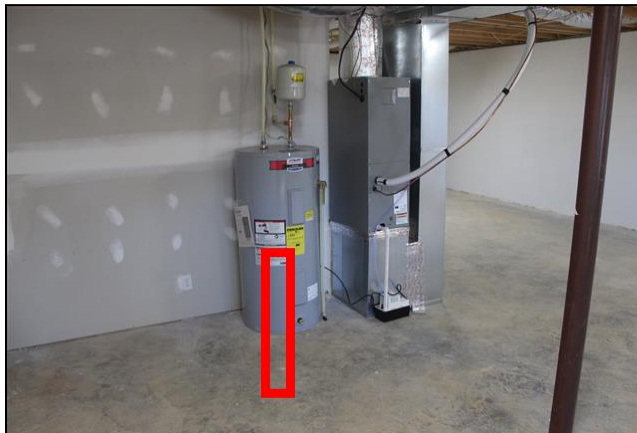
5.3 Item 1(Picture)

**5.3** The water heater was missing a protective bollard to prevent damage to appliance from contact with vehicles entering the garage. A protective bollard should be installed.

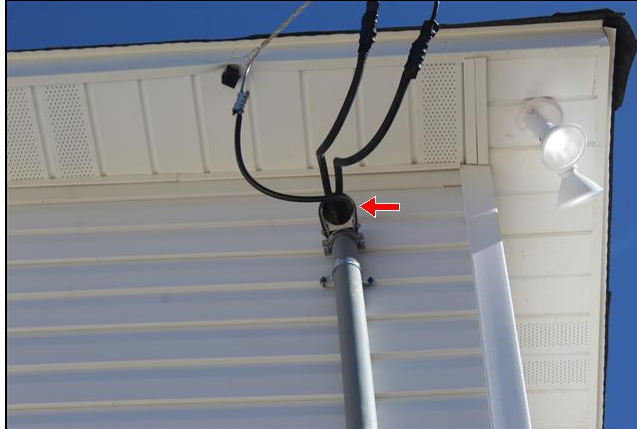
6.0 Item 1(Picture)

**6.0** The weather head was observed to be missing its insulated wire bushing which is part of this listed assembly. Corrections are needed for proper installation.

The weather head was observed to be missing its insulated wire bushing which is part of this listed assembly. Corrections are needed for proper installation.

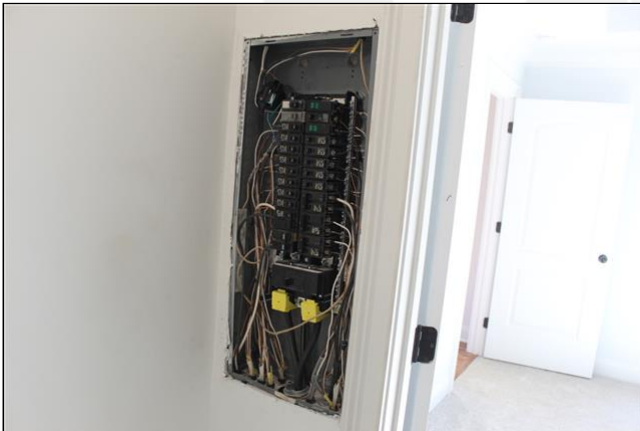
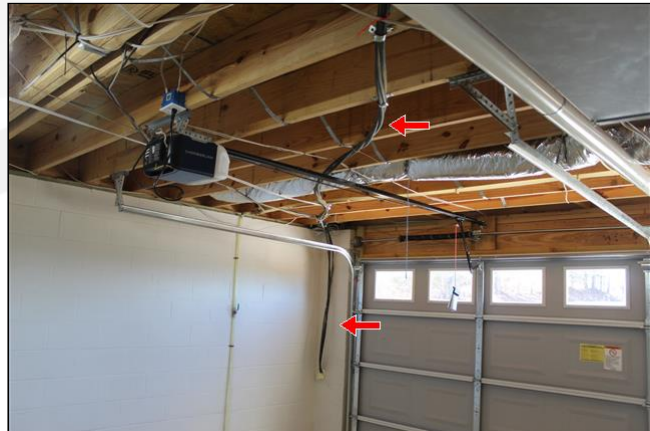
6.1 Item 1(Picture)

**6.1 (1)** Improper ground neutral isolation on the load side of the service disconnect will need correcting, improper 3 wire feed.

(1) Improper ground neutral isolation on the load side of the service disconnect will need correcting, improper 3 wire feed.

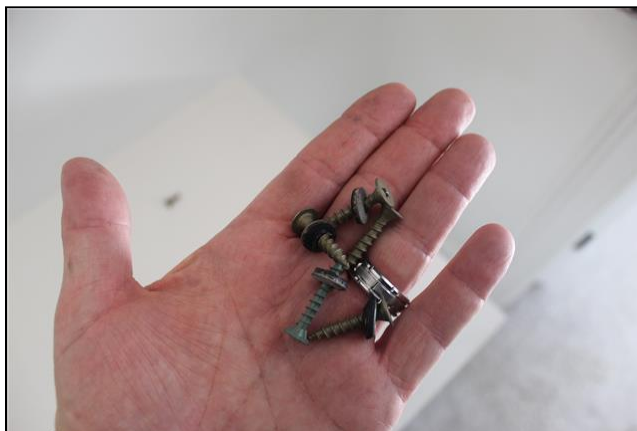
6.1 Item 3(Picture)

**6.1 (2)** Pointed screws at panel front will need to be replaced with blunt tip screws.

(2) Pointed screws at panel front will need to be replaced with blunt tip screws.

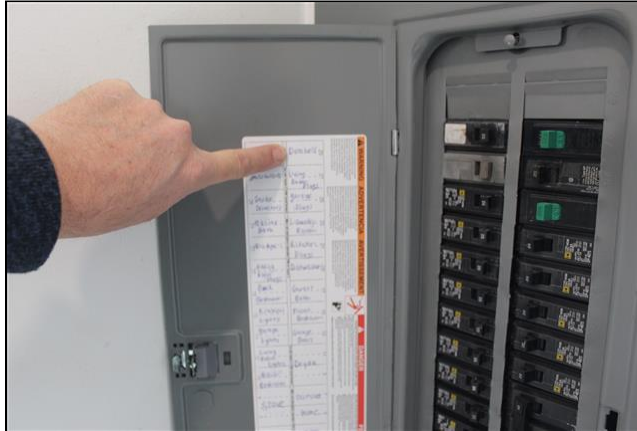
6.1 Item 4(Picture)

**6.1 (3)** Each disconnecting means for motors and appliances, and each service, feeder, or branch circuit at the point where it originates, shall be correctly and legibly marked to indicate its purpose unless located and arranged so the purpose is evident. The marking shall be capable of withstanding the environment involved.

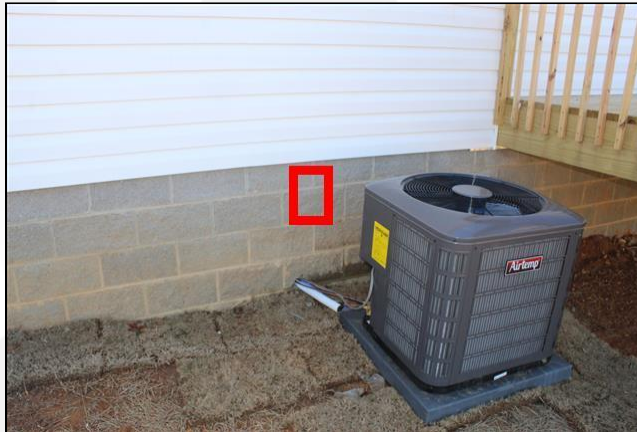
6.2 Item 1(Picture)

**6.2 (1)** The air-conditioning equipment outside was observed to be missing a service disconnect. Disconnecting means shall be located within sight from and readily accessible from the air-conditioning equipment.

(1) The air-conditioning equipment outside was observed to be missing a service disconnect. Disconnecting means shall be located within sight from and readily accessible from the air-conditioning equipment.

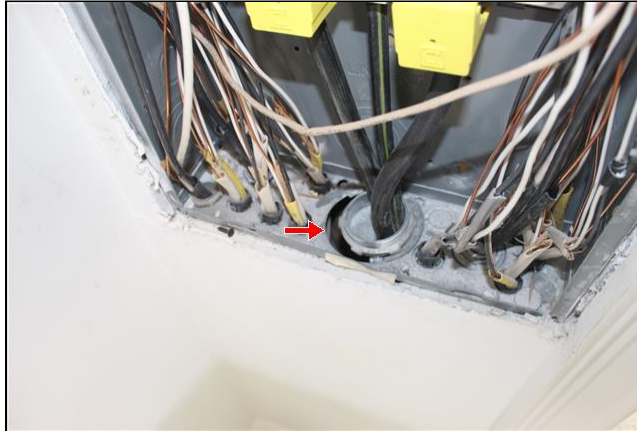
6.2 Item 2(Picture)

**6.2 (2)** All conduit and cables entering the equipment shall be fastened with approved connectors. The concentric knock-out was observed to have been completely removed and the wire connector loosely sitting in the opening without a bonding bushing.

(2) All conduit and cables entering the equipment shall be fastened with approved connectors. The concentric knock-out was observed to have been completely removed and the wire connector loosely sitting in the opening without a bonding bushing.

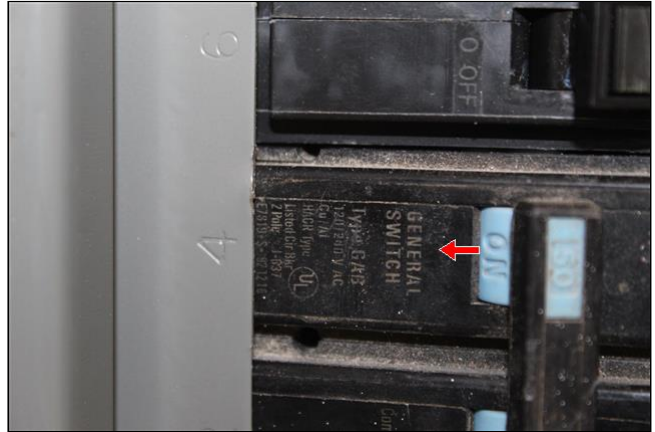
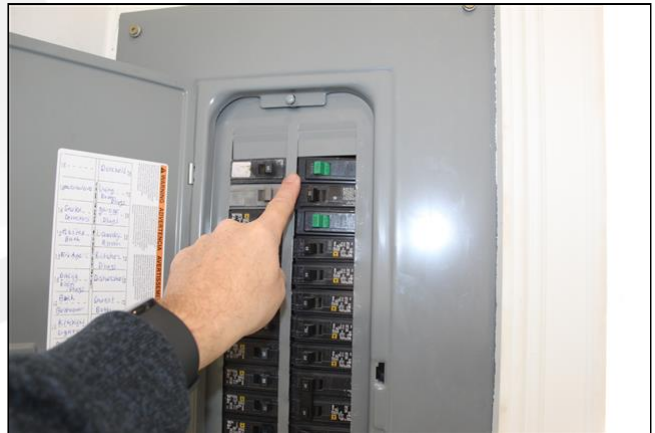
6.2 Item 4(Picture)

**6.2 (4)** Breakers installed of improper manufacturer (Each panel manufacturer designs their electrical panel for their breakers only; while it is possible other manufactures breakers may fit into another manufacturers box, often times they must be altered in order to fit which is unsafe.) Observed several breakers installed at this panel which did not seat properly on the bus bar.

(4) Breakers installed of improper manufacturer (Each panel manufacturer designs their electrical panel for their breakers only; while it is possible other manufactures breakers may fit into another manufacturers box, often times they must be altered in order to fit which is unsafe.) Observed several breakers installed at this panel which did not seat properly on the bus bar.

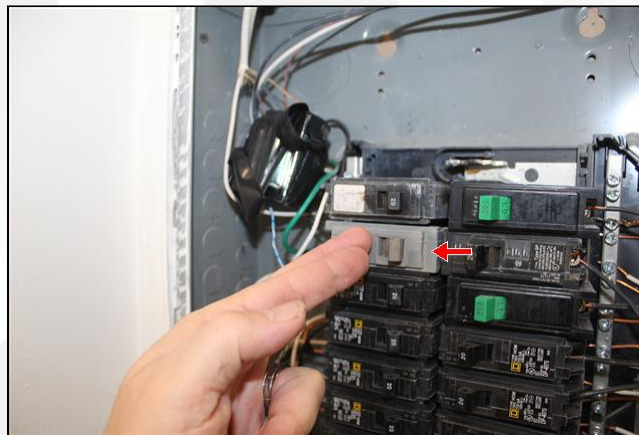
6.2 Item 11(Picture)

**6.2 (6)** Overcurrent protective devices shall not show evidence of deterioration or damage. Observed 1 breaker in which the rating was no longer visible, this breaker will need to be verified or replaced as proper size for the conductor connected to it.

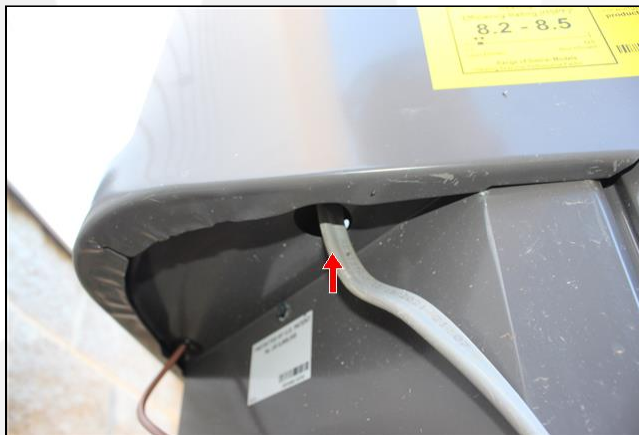
6.3 Item 1(Picture)

**6.3 (1)** Conductors shall be terminated, spliced and taped as required at devices, outlets and boxes in an approved method. An electrical splice / exposed conductors must be contained inside a junction box with a cover plate or an approved N.M. Cable Interconnector.

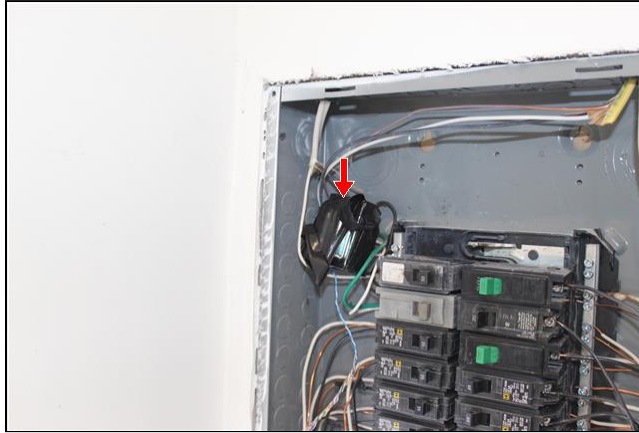
6.3 Item 2(Picture)

**6.3 (2)** Cables and conductors of Class 2 circuits shall not be placed inside the service panel enclosure. The door bell transformer and related Class 2 conductors will need to be removed from the service panel enclosure.

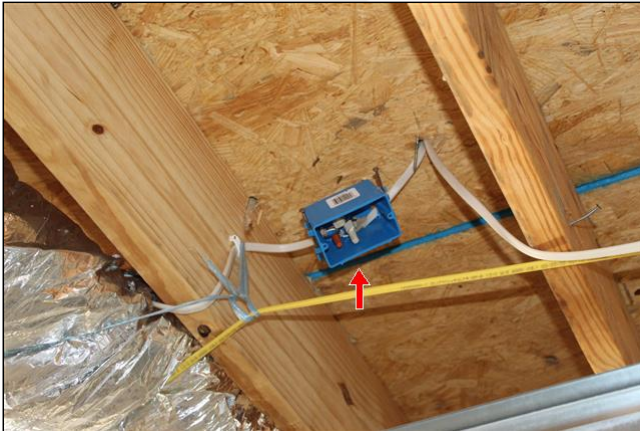
6.3 Item 3(Picture)

**6.3 (3)** Damaged or missing outlet / junction covers will need to be replaced.

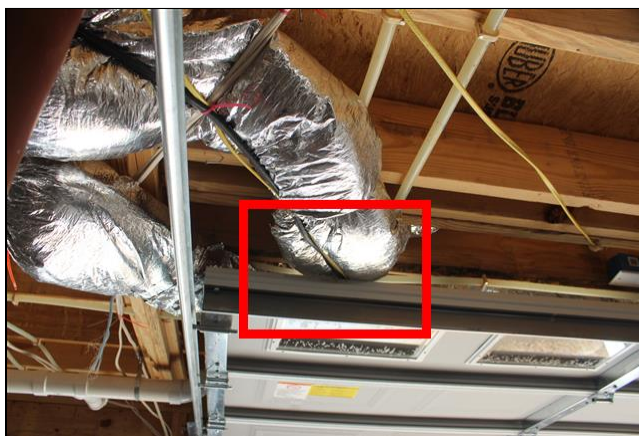
6.3 Item 5(Picture)

**6.3 (4)** Conductors, cables, cable assemblies and conduit shall not show evidence of deterioration, damage, or physical abuse. The garage door was observed to rub against electrical wiring when the door is opened/closed. The wiring in this location should be relocated as to prevent the wiring from becoming damaged from the door.

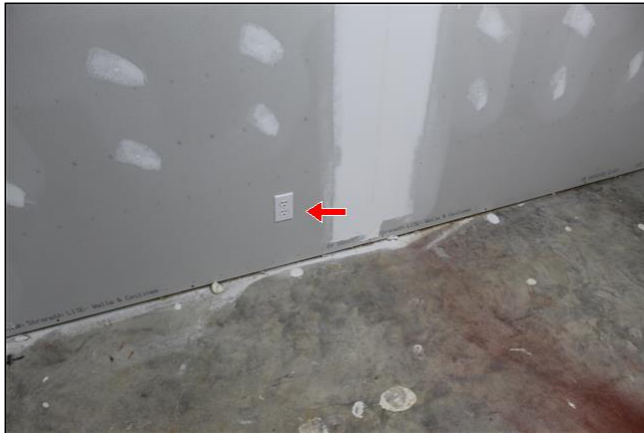
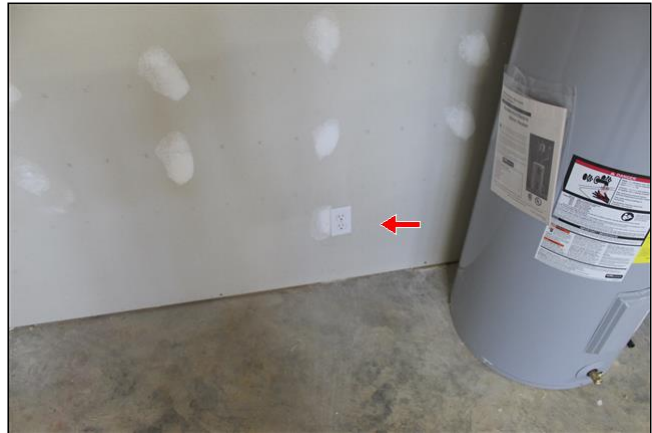
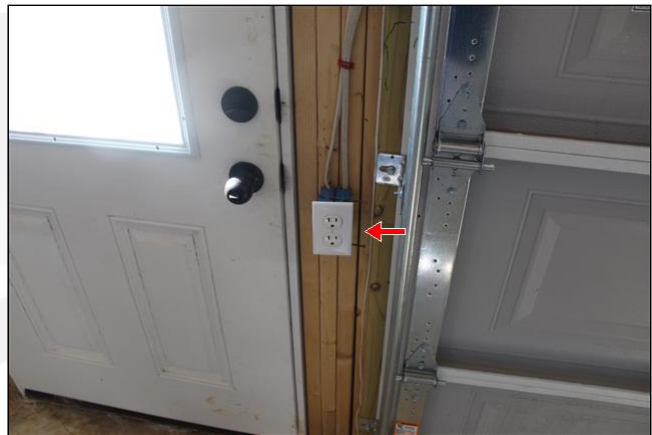
6.4 Item 1(Picture)

**6.4** One or more GFCI (Ground Fault Circuit Interrupter) receptacles did not trip/reset when tested (defective/missing) which should be corrected for electrical safety.

1. Garage

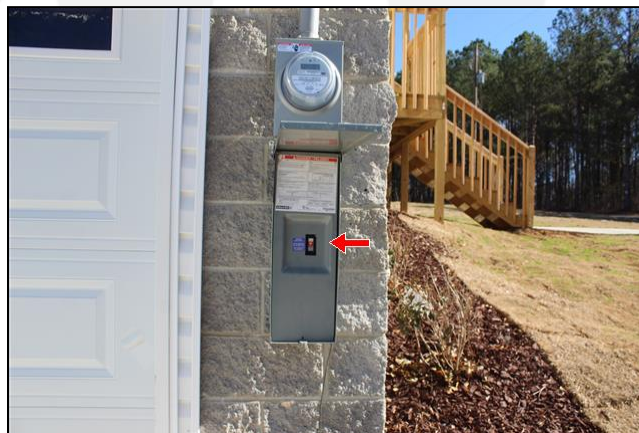
6.6 Item 1(Picture)

**6.6 (1)** The main service disconnect is located outside.

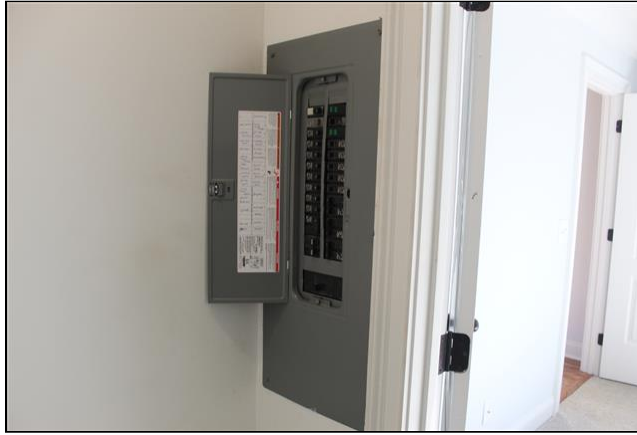
6.6 Item 2(Picture)

6.6 (2) The main panel box is located at the primary bedroom closet.

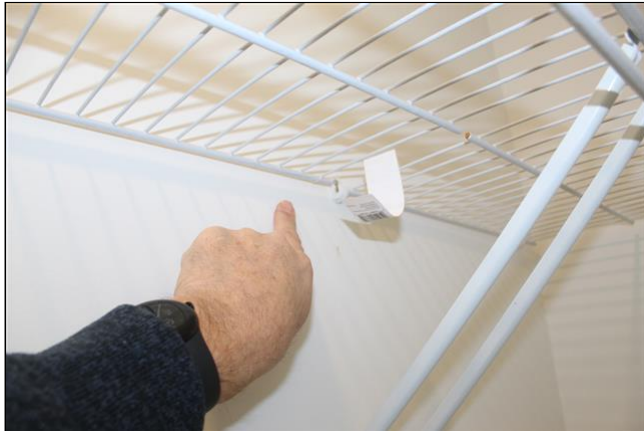
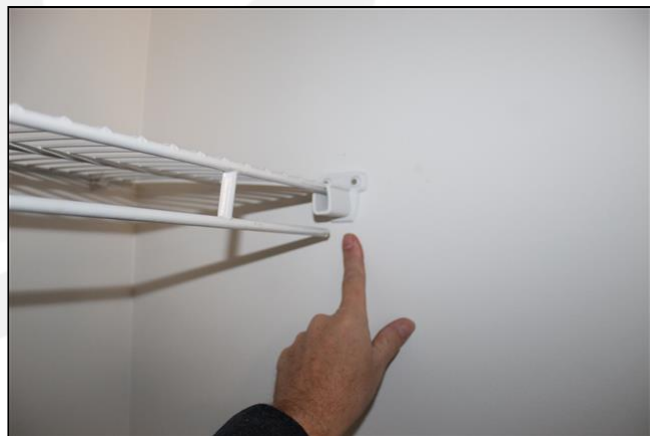
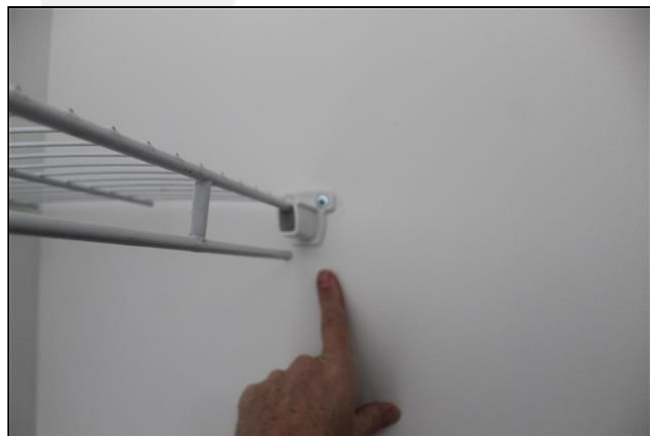
7.4 Item 1(Picture)

**7.4** Loose closet shelving will need to be secured. Observed missing back clips, missing bracing and the wrong end caps. Corrections are needed for proper installation.

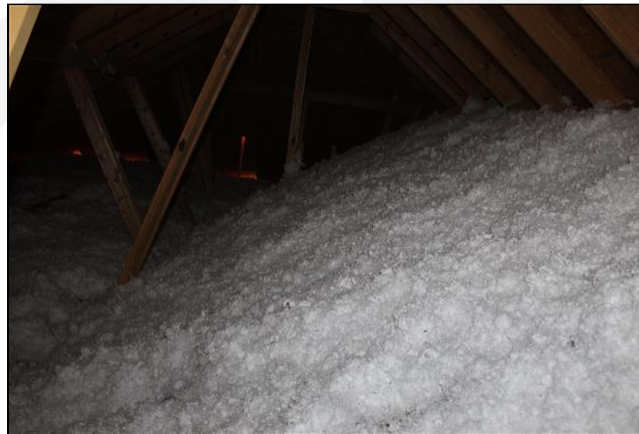
8.0 Item 1(Picture)

8.0 (1) Attic insulation is about 12 inches thick or 30 R Value.

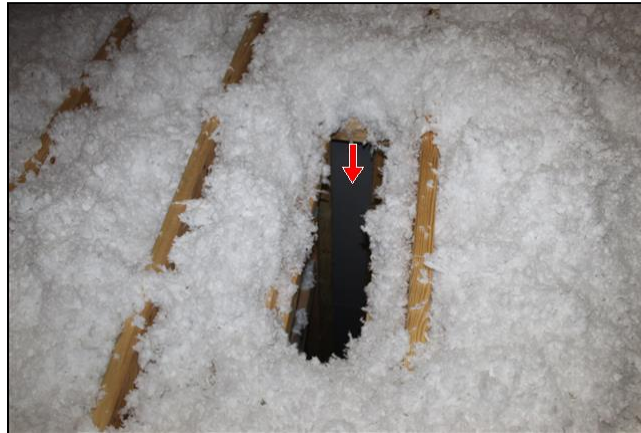
8.0 Item 2(Picture)

8.0 (2) Observed at least one chase penetration that was not insulated. Energy loss is occurring where areas of the attic are not insulated. Capping these areas and insulating will help prevent further energy loss at these locations.

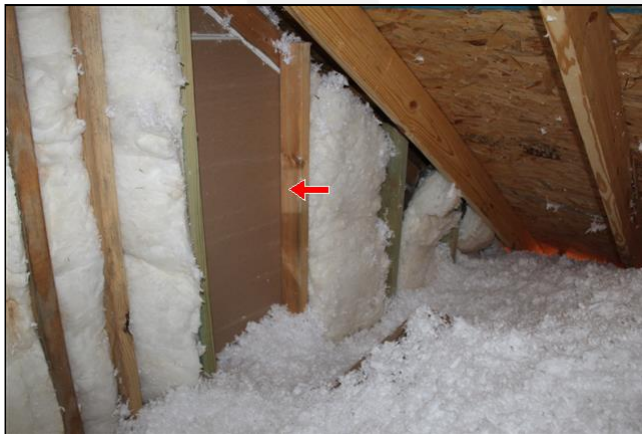
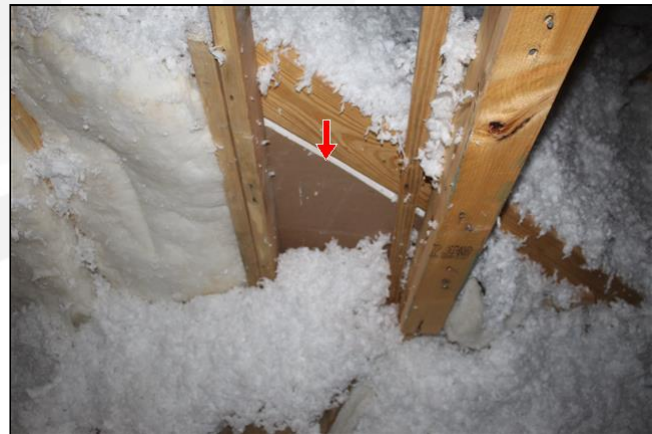
8.0 Item 3(Picture)

8.0 (3) Observed loose or missing batt insulation at sidewall(s) inside the attic which should be corrected. Heat loss can occur more on this home than one that is properly insulated.

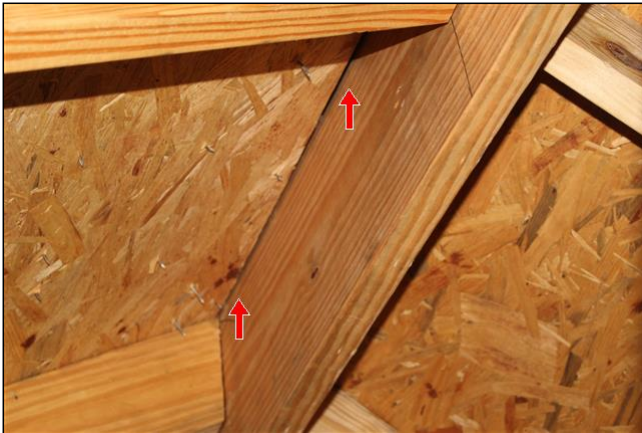
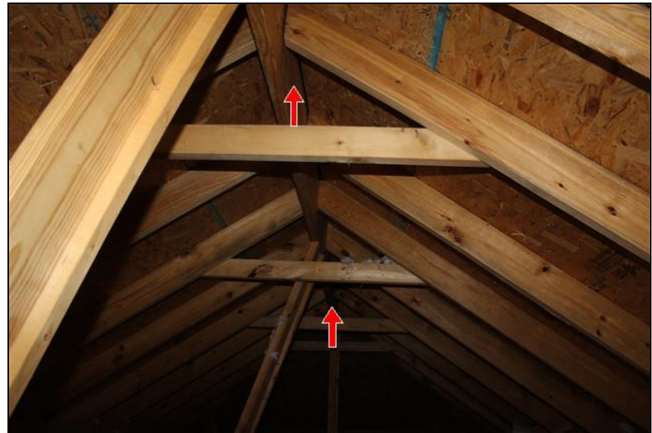
8.2 Item 1(Picture)

**8.2** The attic space was observed to be poorly vented at the ridge vent as the roof decking was not cut back in accordance with manufactures installation instructions. Roof decking should be cut back 3/4" on both sides of ridge centerline or from ridge board.

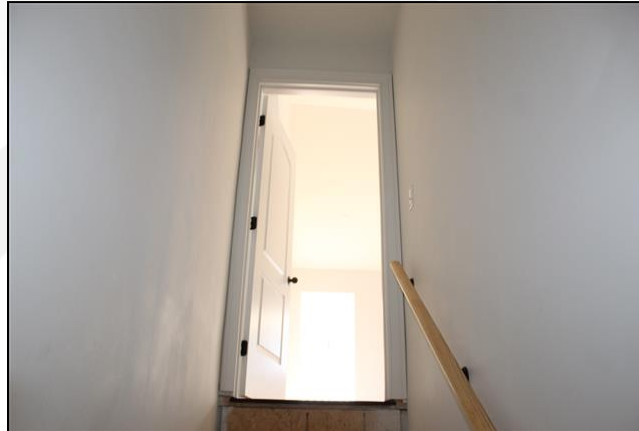
9.4 Item 1(Picture)

**9.4** Doors between house and garage rated 20-min or 1 3/8 in. solid wood or honeycomb core steel. This door should be complete with weather stripping including threshold.

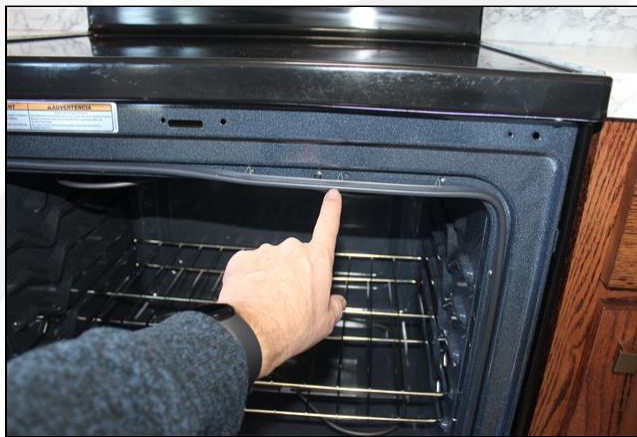
10.1 Item 1(Picture)

**10.1** The range door seal was observed to be loose which will need correction prior to use.

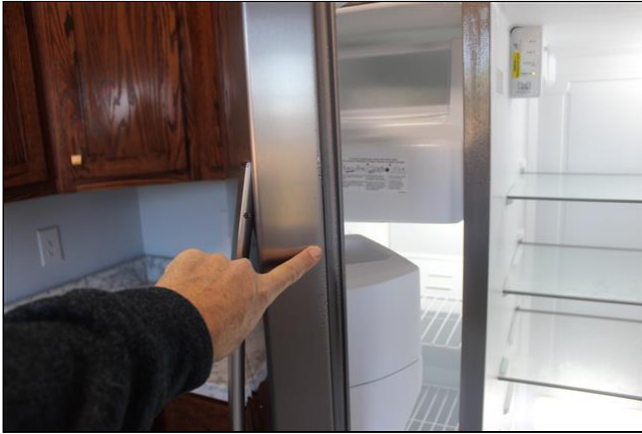
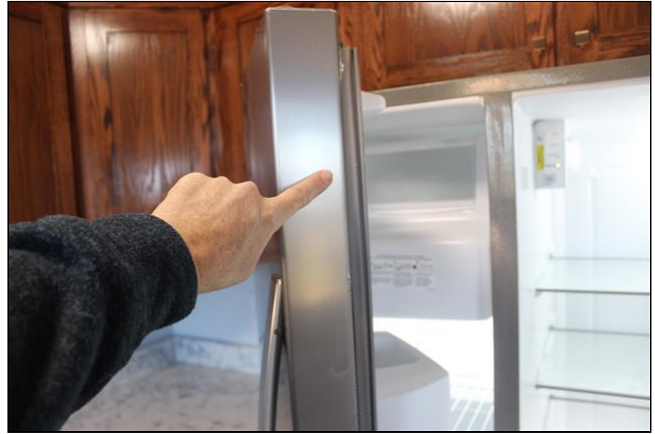
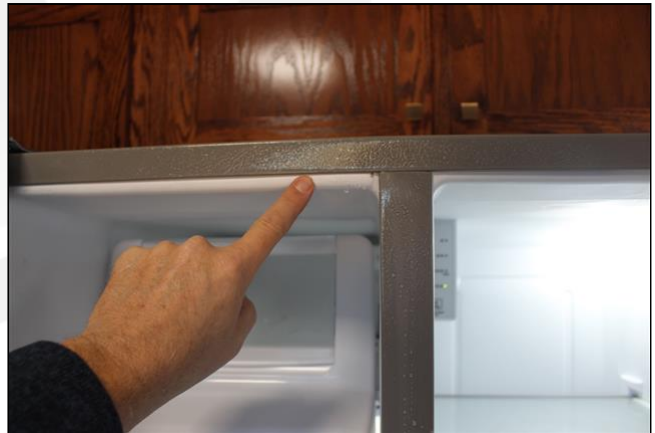
10.4 Item 1(Picture)

**10.4** The refrigerator was observed to run throughout the entire inspection period from what appeared as leaky door seals. Upon opening the doors condensation was observed on the freezer door and the metal frame between the doors indicating seal failure. Further evaluation is needed to determine the cause and repairs performed as needed to restore functionality.
