# Inspection Report

## Westbrook Homes, LLC

123 Sample St

<b>Date:</b> 2/6/2023	<b>Time:</b> 08:00:00 AM	<b>Report ID:</b> 262023-1752
<b>Property:</b> 123 Sample St Adamsville AL 35071	<b>Customer:</b> Sample Report	<b>Real Estate Professional:</b> Crystal Westbrook Keller Williams Metro North

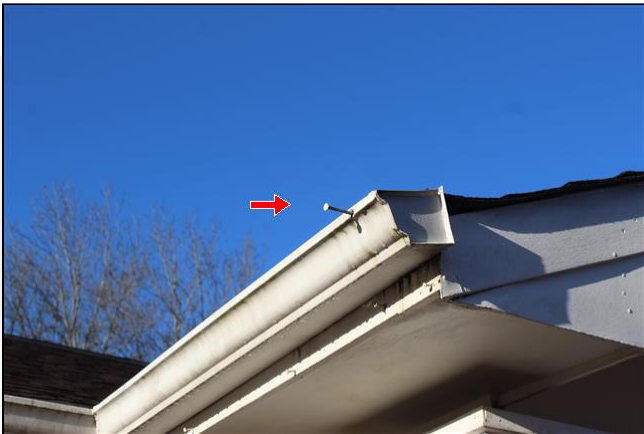
1.3 Item 1(Picture)

1.3 (1) Loose roof drainage systems will need securing where loose.

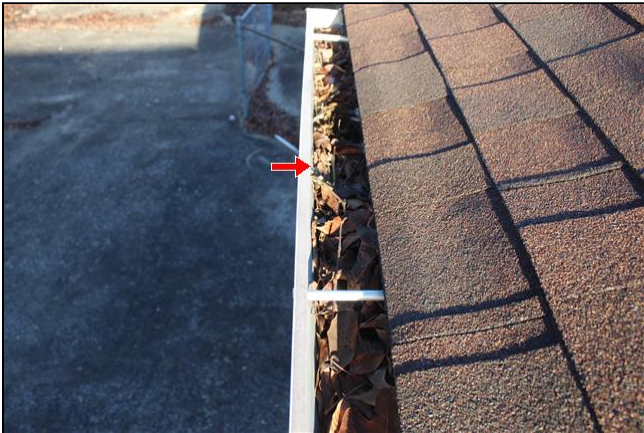
1.3 Item 2(Picture)

1.3 (2) The gutters are full of debris in areas, keeping the roof drainage system clean helps divert water away from the foundation. Monitor and keep clean for optimal performance.

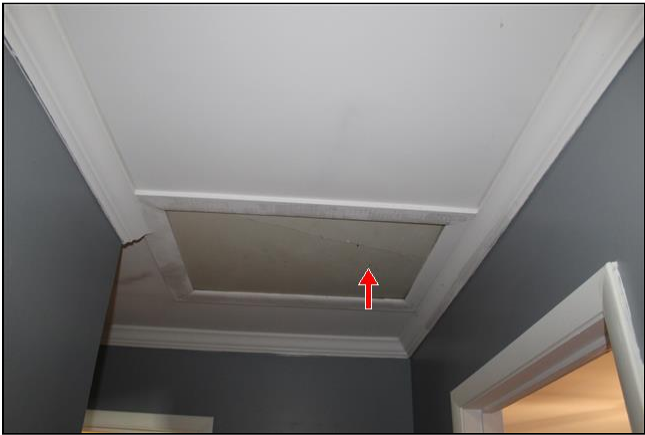
1.4 Item 1(Picture)

1.4 The attic access sheetrock door was observed to be broken at time of inspection.

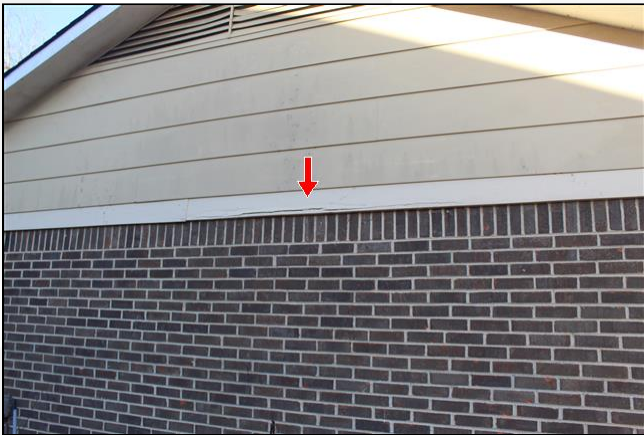
2.0 Item 1(Picture)

**2.0 (1)** Areas of deteriorated siding will need to be repaired, scrapped to remove loose paint, primed, caulked and painted to prevent further deterioration.

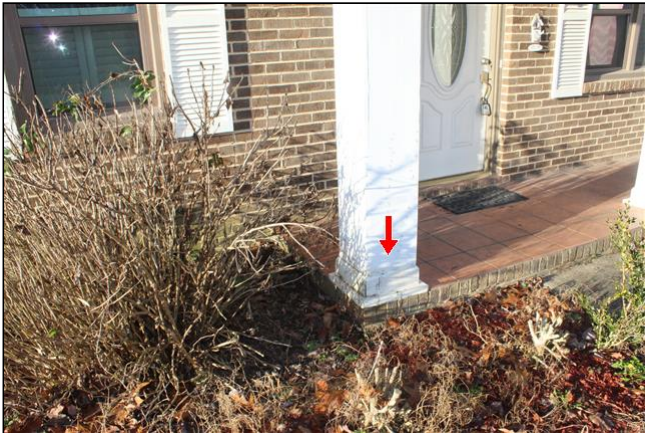
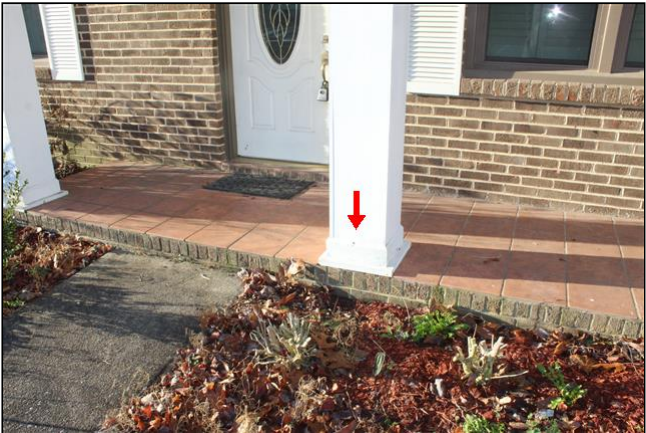
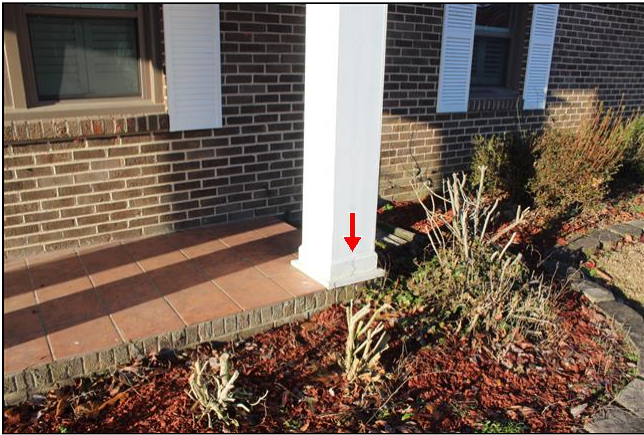
2.0 Item 2(Picture)

**2.0 (2)** Areas of bare siding / peeling / chalking paint need to be scrapped to remove loose paint, primed, caulked and painted as to restore the intended protection it provides.

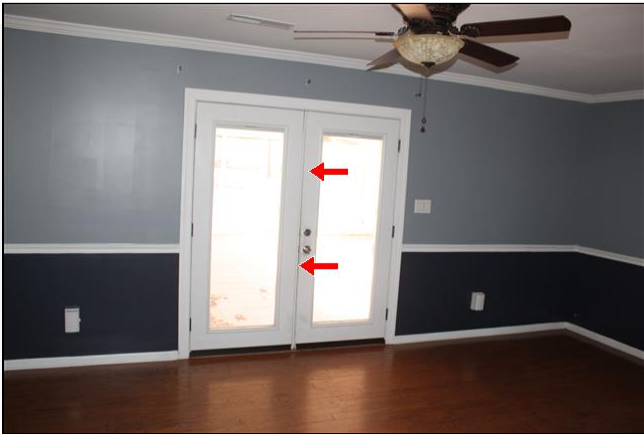
2.2 Item 1(Picture)

2.2 Damaged weather stripping should be replaced.

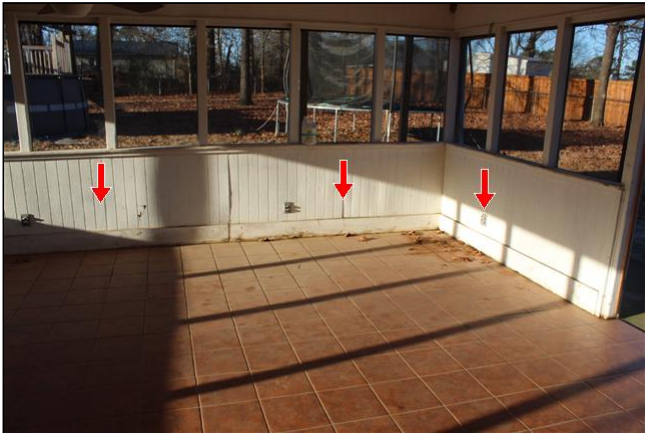
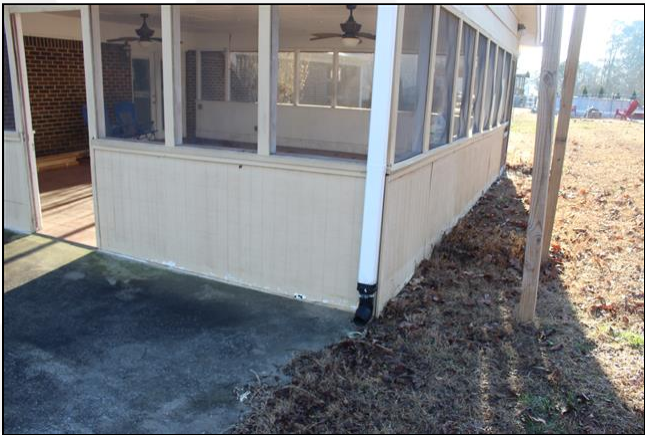
2.4 Item 1(Picture)

**2.4** The rear patio wall covering was observed to have minor deterioration around the base of the covering. This is due to the grade on the outside of this patio. The structural components were not able to be evaluated due to the covering installed. Due to the grade around this area it is my opinion that a better solution would be to remove the covering as to expose the structural framing and simply screen it down to the floor, this would provide better air flow to allow the framing to dry more quickly and allow for evaluation / monitoring of the structural components. No indications of concern observed however, further evaluation of the structural components should be performed in the near future.

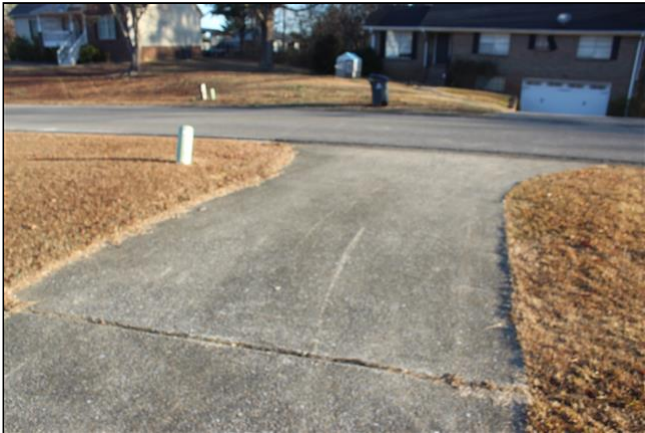
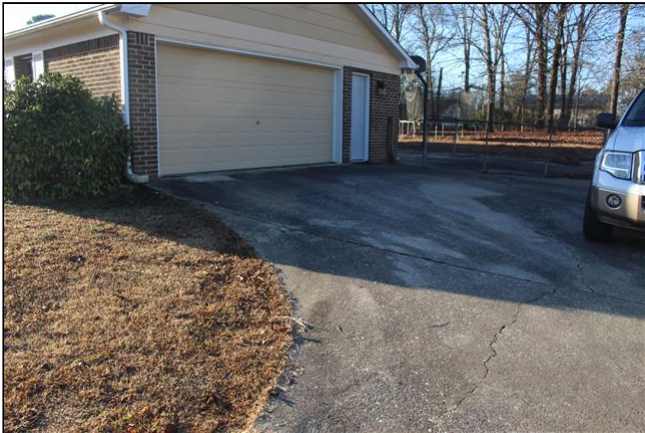
2.6 Item 1(Picture)

**2.6** Observed minor cracking in the driveway slab at the exterior, however we did not observe any concerns associated with these cracks at time of inspection.

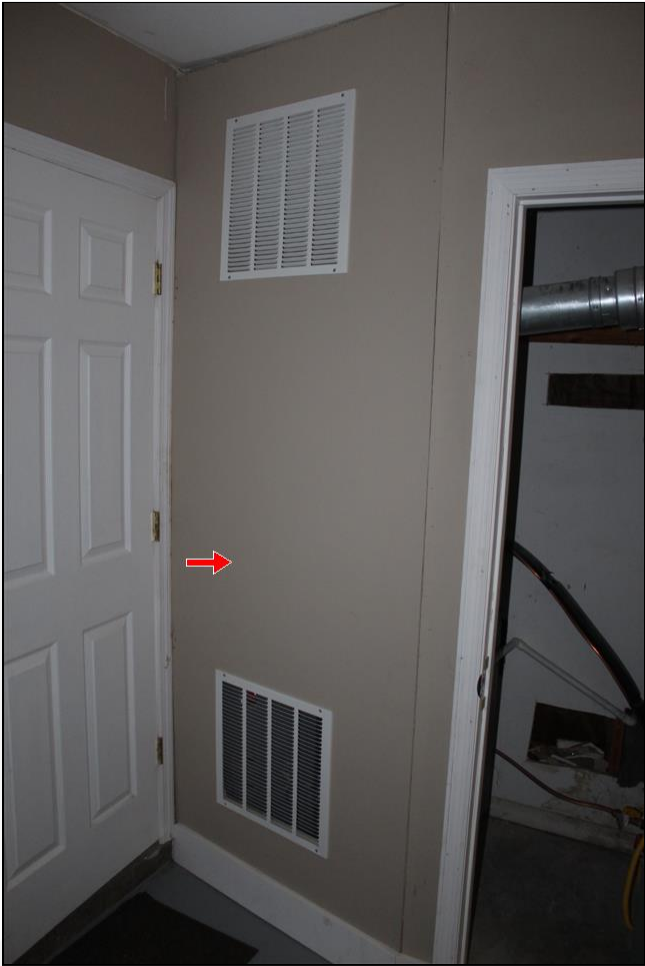
4.0 Item 1(Picture)

4.0 The furnace was observed to not be accessible without removing a section of wall / baseboard. The furnace should have an operable door for access and service.

**Recommendation:** A qualified HVAC contractor should inspect further and make corrections to item(s) identified in this inspection report as well as any other related condition discovered while performing repairs.

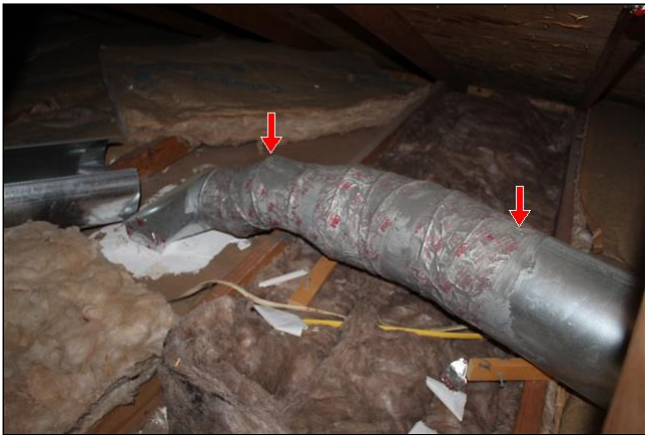
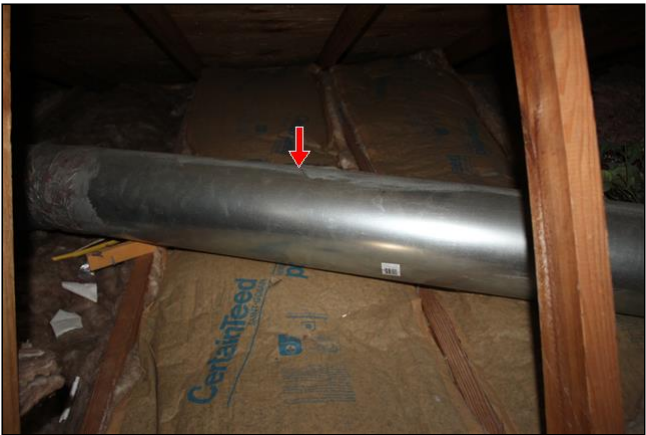
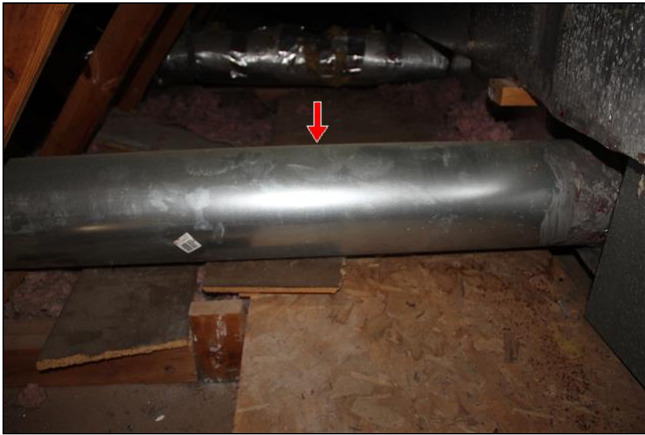
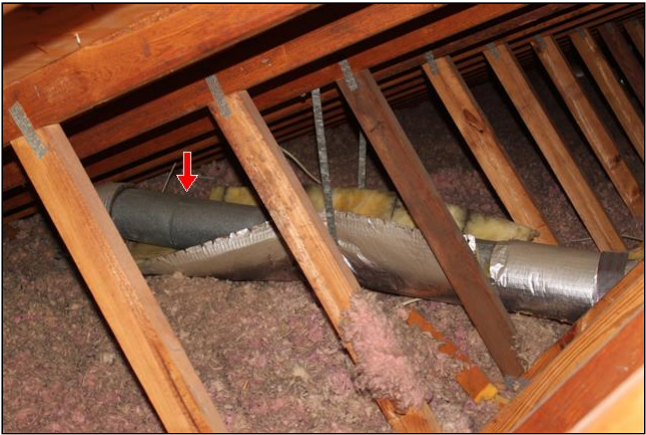
4.3 Item 1(Picture)

4.3 Loose/Missing insulation on supply ducts should be installed/corrected.

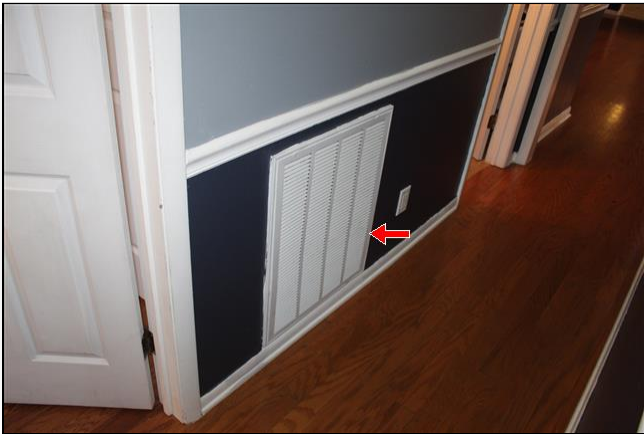
4.6 Item 1(Picture)

4.6 The filter is located in the common hallway wall.

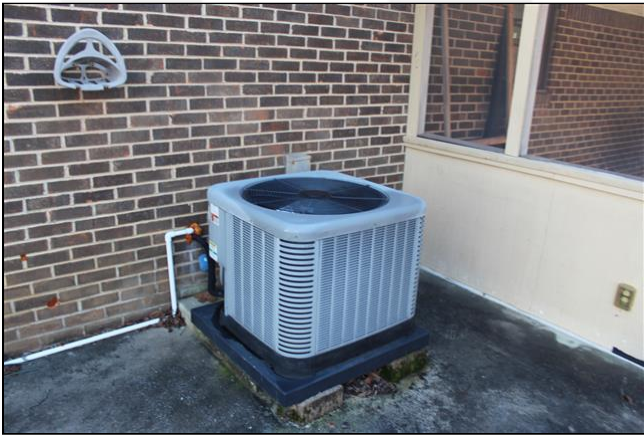
4.7 Item 1(Picture)

4.7 Due to outside temperatures below 65 degrees at time of inspection we were unable to test the cooling system(s) of the home. A visual inspection only was performed on the cooling system.

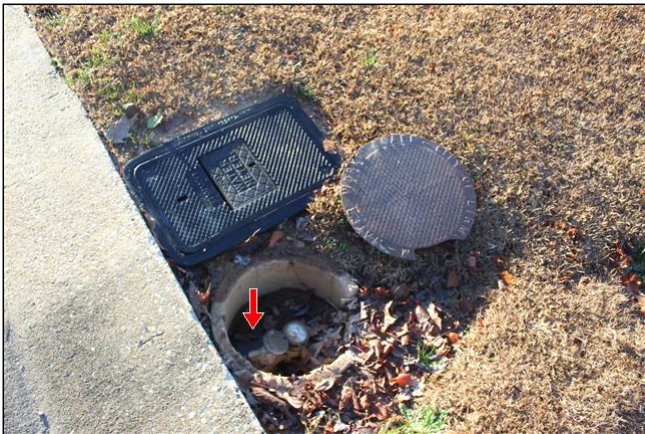
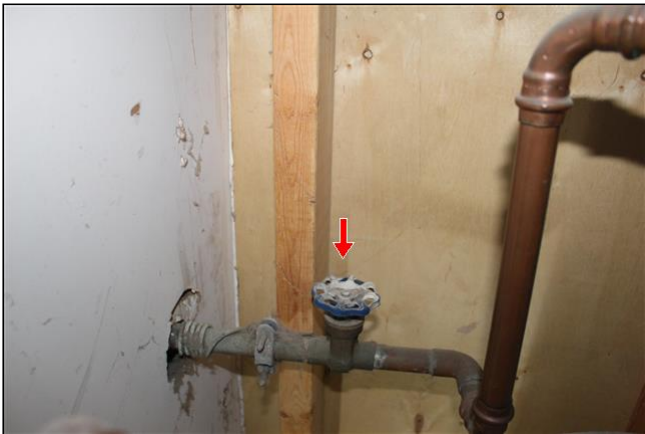
5.0 Item 1(Picture)

5.0 The main shut off is located outside in the ground at the water meter. There is also a shutoff at the water heater.

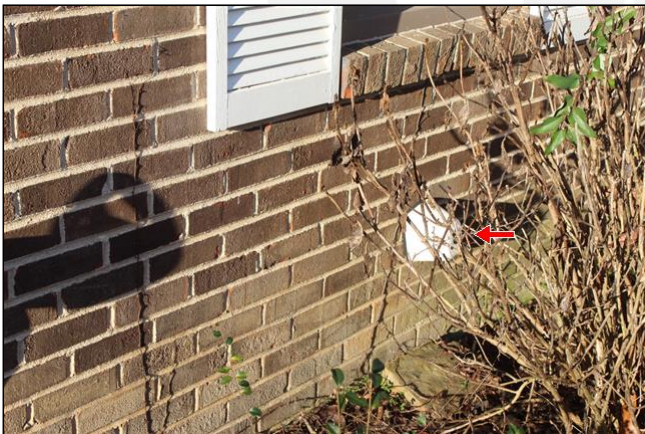
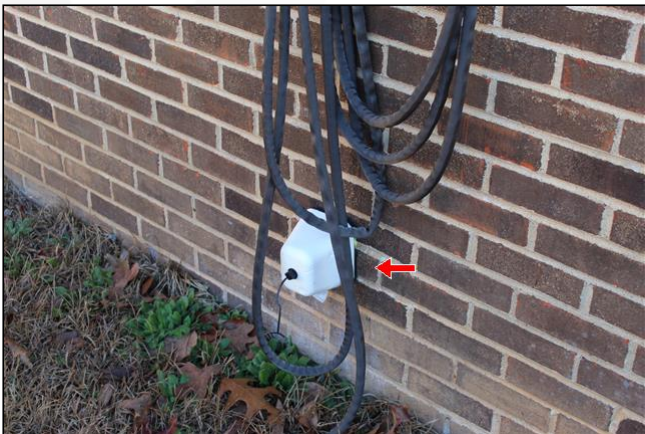
5.6 Item 1(Picture)

5.6 The outdoor water faucets have been winterized, we did not test winterized fixtures for operation.

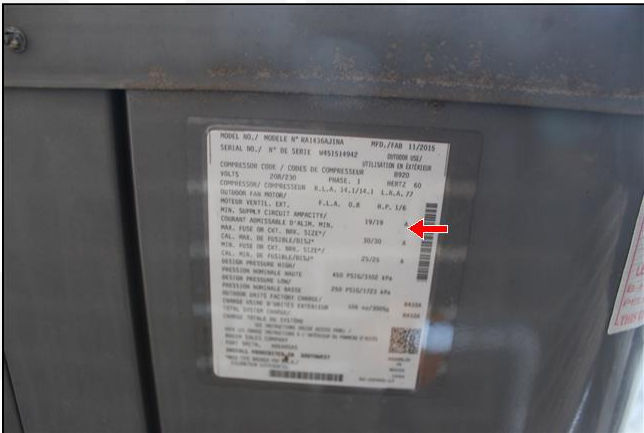
6.1 Item 2(Picture)

**6.1** (2) Due to missing labeling at the electrical panel, we are unable to confirm proper amperage of the unlabeled breakers in association with the HVAC system at time of inspection.

(2) Due to missing labeling at the electrical panel, we are unable to confirm proper amperage of the unlabeled breakers in association with the HVAC system at time of inspection.
-

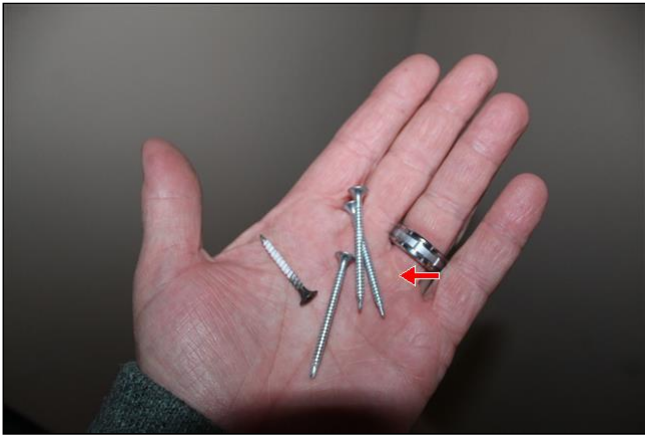
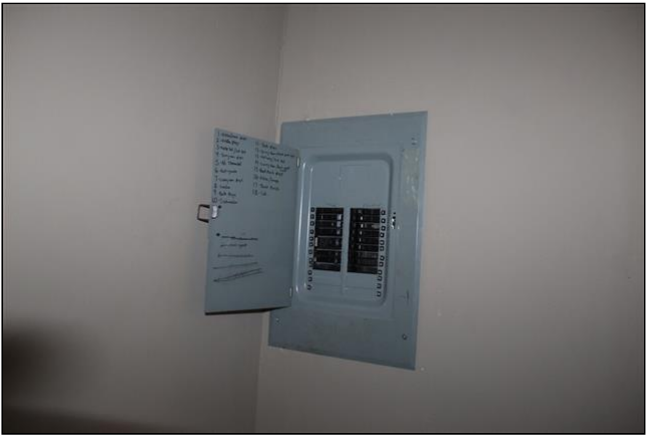
6.1 Item 3(Picture)

**6.1 (3)** Pointed screws at panel front will need to be replaced with blunt tip screws.

(3) Pointed screws at panel front will need to be replaced with blunt tip screws.
-

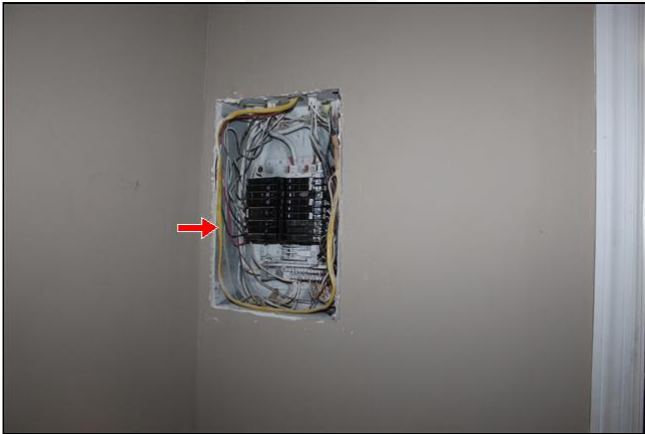
6.2 Item 3(Picture)

**6.2 (3)** Observed multiwire branch circuit(s) at the electrical panel. Each multi-wire branch circuit must have a means to simultaneously disconnect all phase conductors at the point where the branch circuit originates.

(3) Observed multiwire branch circuit(s) at the electrical panel. Each multi-wire branch circuit must have a means to simultaneously disconnect all phase conductors at the point where the branch circuit originates.

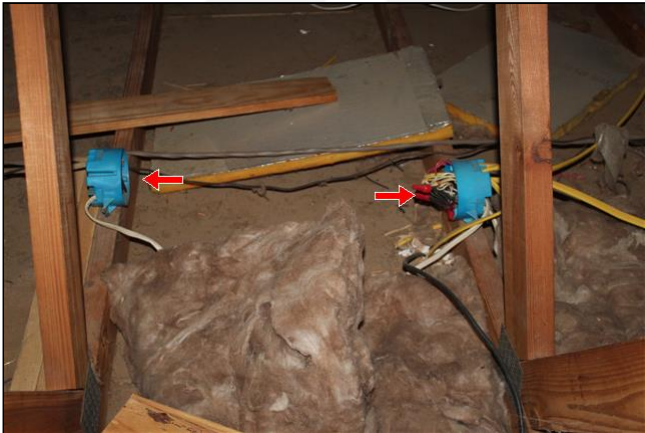
6.3 Item 4(Picture)

**6.3 (2)** Damaged or missing outlet / junction covers will need to be replaced.

(2) Damaged or missing outlet / junction covers will need to be replaced.
-

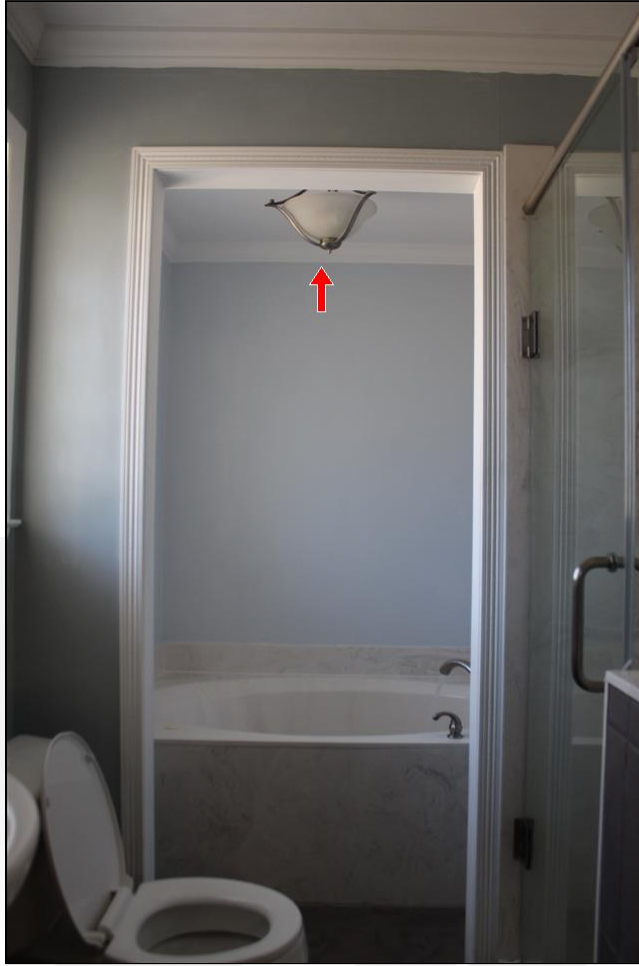
6.3 Item 6(Picture)

**6.3 (3)** No cord-connected or pendant luminaires, lighting track, or ceiling-suspended paddle fans within 8' above the tub rim or shower threshold & for a zone extending 3' outside these areas for safety.

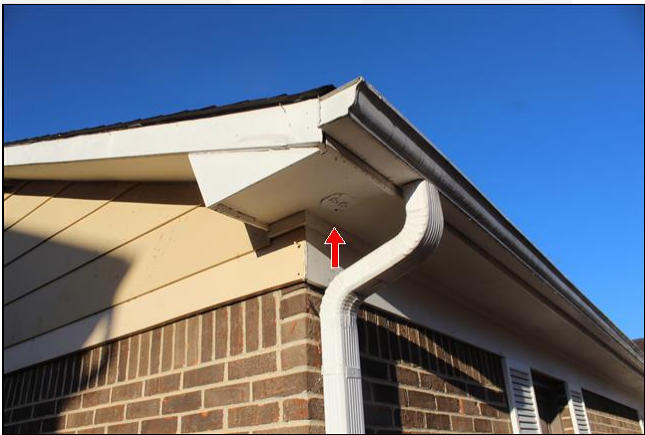
6.4 Item 13(Picture)

**6.4 (2)** Outlets installed in a damp or wet location must be installed in a weatherproof enclosure.

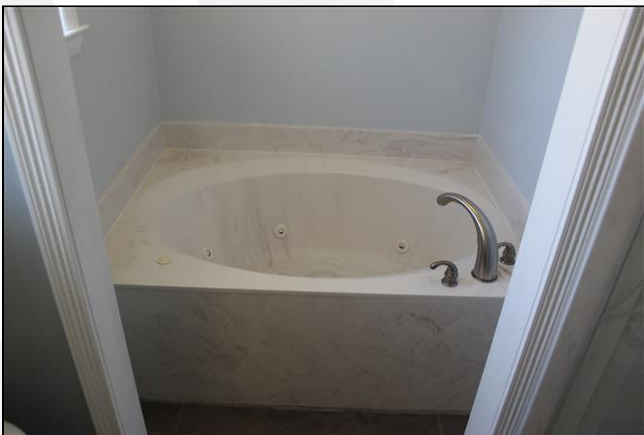
6.4 Item 16(Picture)

**6.4 (4)** A GFCI (Ground Fault Circuit Interrupter) receptacle or breaker for the jetted tub in the Primary Bath could not be located at time of inspection which will need to be installed for safety.

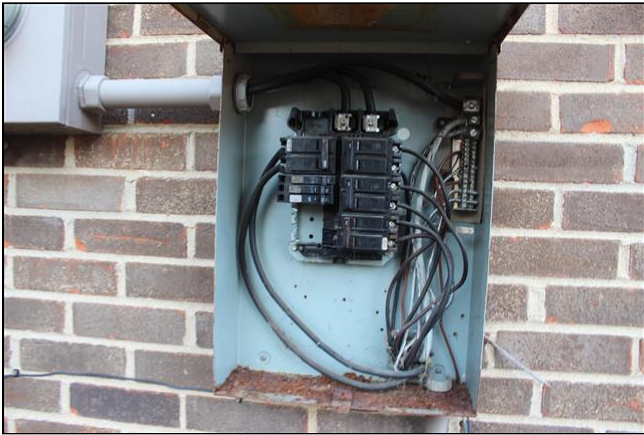
6.6 Item 3(Picture)

**6.6 (1)** The main service disconnect is located outside.

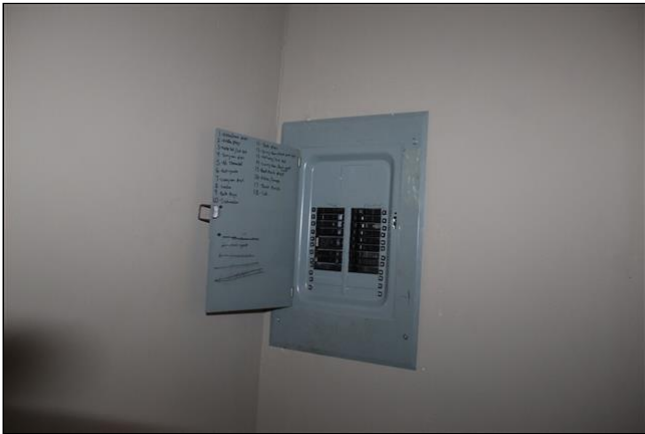
6.6 Item 4(Picture)

6.6 (2) The sub panel box is located at the hallway.

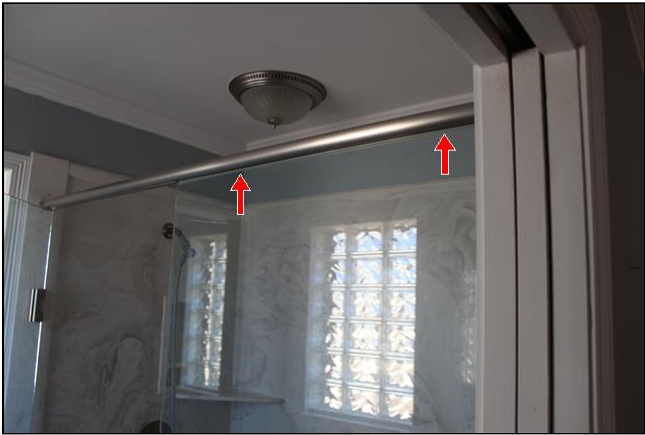
7.1 Item 1(Picture)

7.1 The shower glass wall was observed to be missing filler at the top rail which allows the glass to be loose inside the frame. Filler should be added to secure the glass.

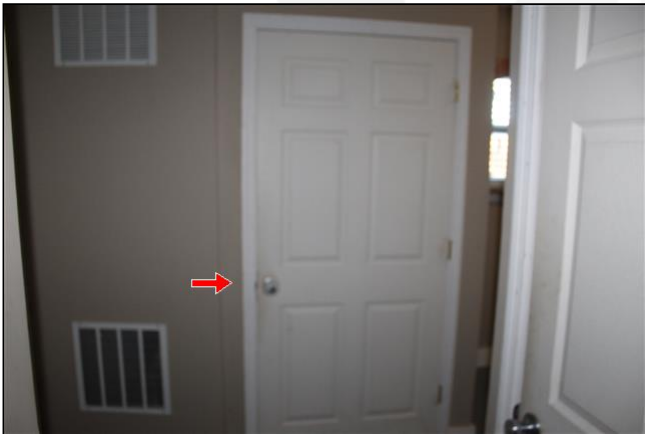
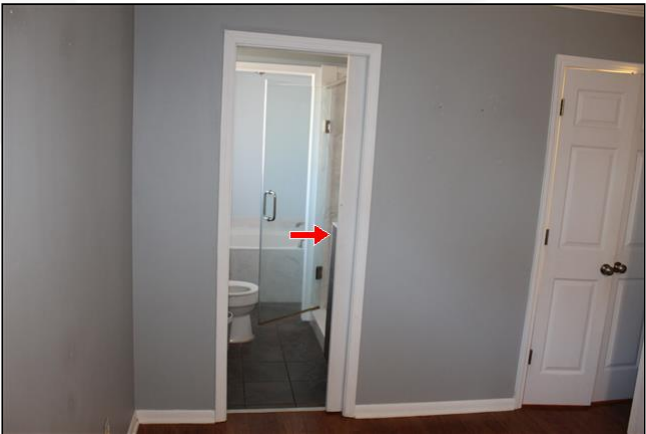
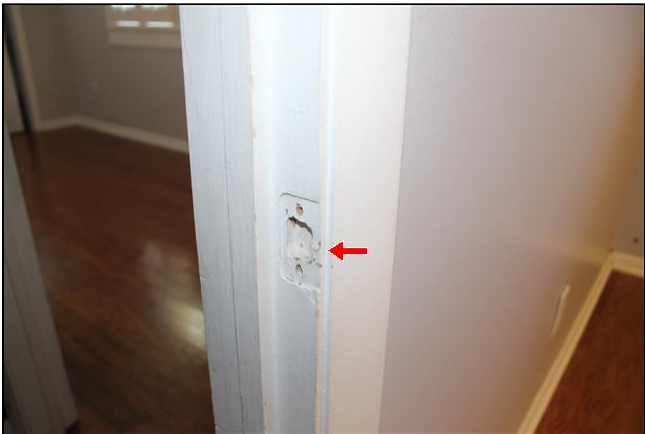
7.5 Item 1(Picture)

7.5 One or more interior doors needs strike/latch/hinge adjustments or missing hardware installed as to shut/latch properly. This is a maintenance issue and is for your information.

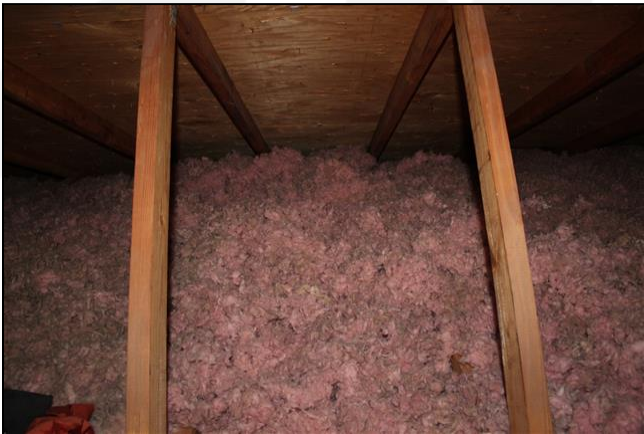
8.0 Item 1(Picture)

8.0 (1) Attic insulation is about 5.5 inches thick or 13 R Value .

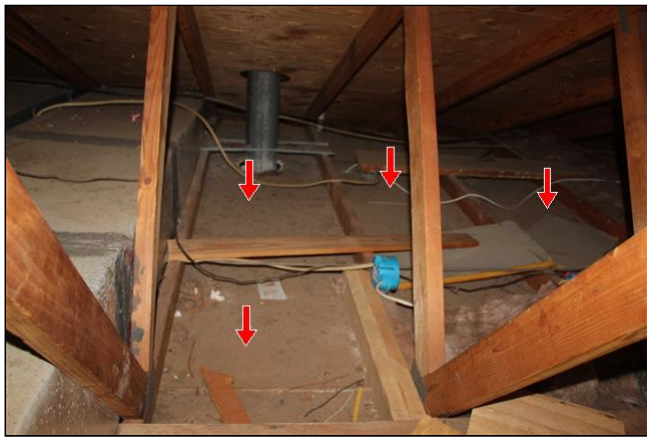
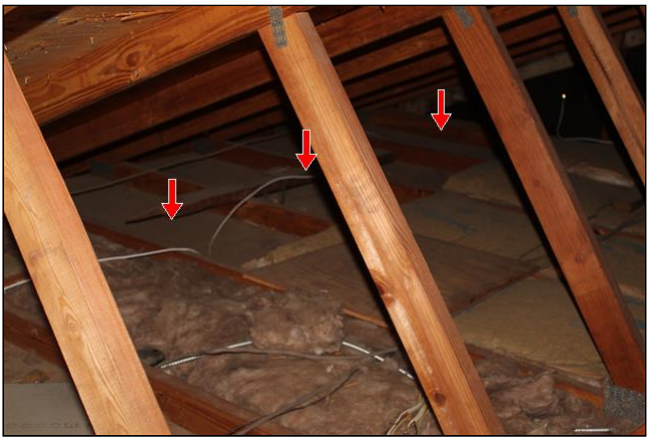
8.0 Item 2(Picture)

8.0 (2) Observed missing insulation in areas inside the attic which will need correction.

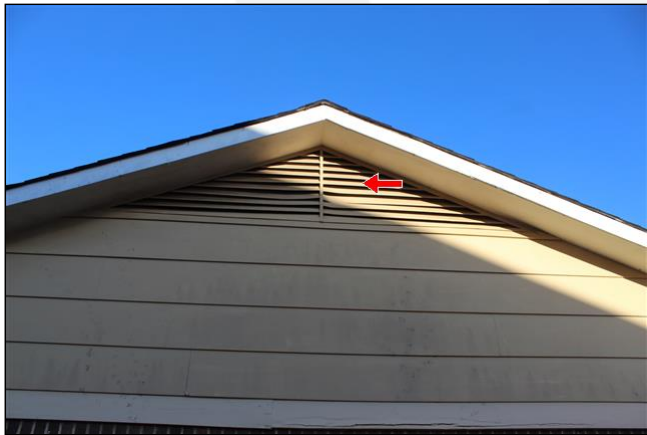
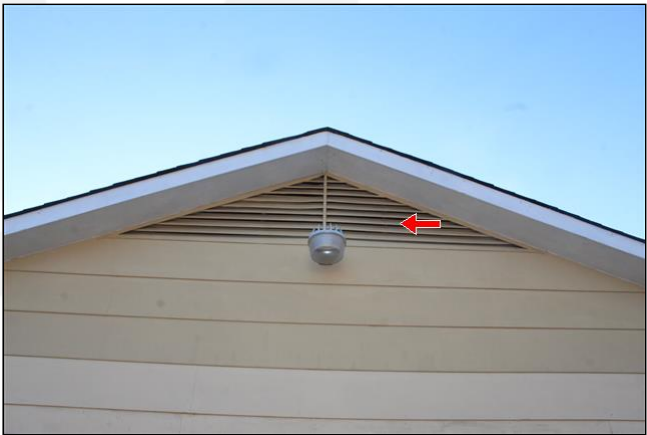
8.1 Item 1(Picture)

8.1 Observed missing or damaged screening at the gable vents in the attic which will need to be replaced as to prevent vermin entry into the attic space. .

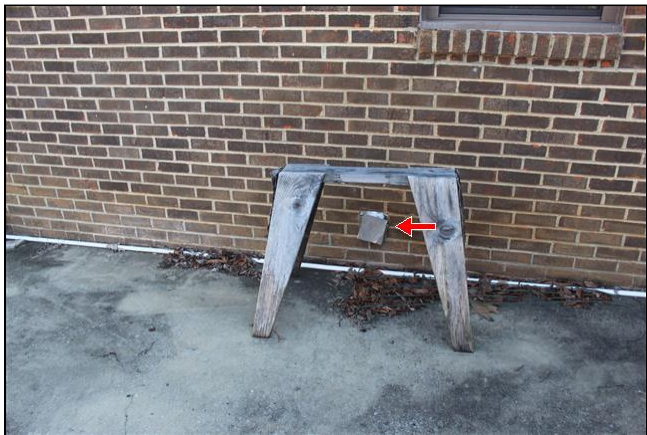
8.2 Item 1(Picture)

8.2 The vent hood for the dryer exhaust at the exterior was observed to be damaged. For fire safety a new hood should be installed and sealed to the siding to repair.

The vent hood for the dryer exhaust at the exterior was observed to be damaged. For fire safety a new hood should be installed and sealed to the siding to repair.

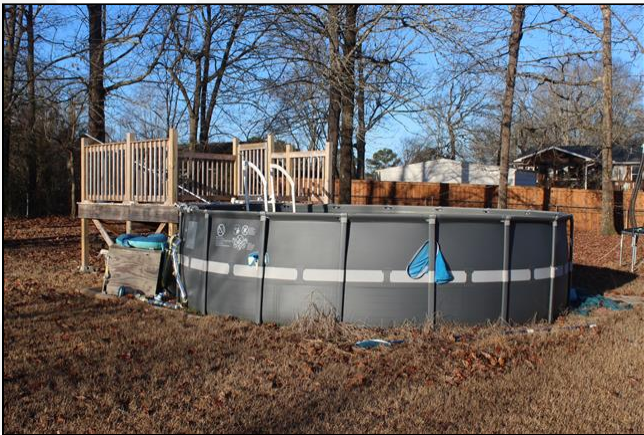
10.0 Item 1(Picture)

**10.0** I did not inspect the pool, pool deck or related electrical around or for the pool. Our company makes no representation to the condition of the pool or related electrical.
