# Inspection Report

## Westbrook Homes, LLC

123 Sample Rd

<b>Date:</b> 1/26/2023	<b>Time:</b> 02:00:00 PM	<b>Report ID:</b> 1262023-4253
<b>Property:</b> 123 Sample Rd Birmingham AL 35071	<b>Customer:</b> Sample Report	<b>Real Estate Professional:</b> Crystal Westbrook Keller Williams Metro North

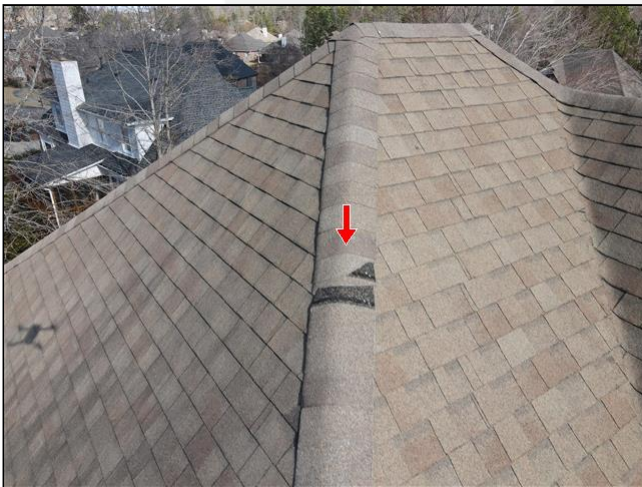
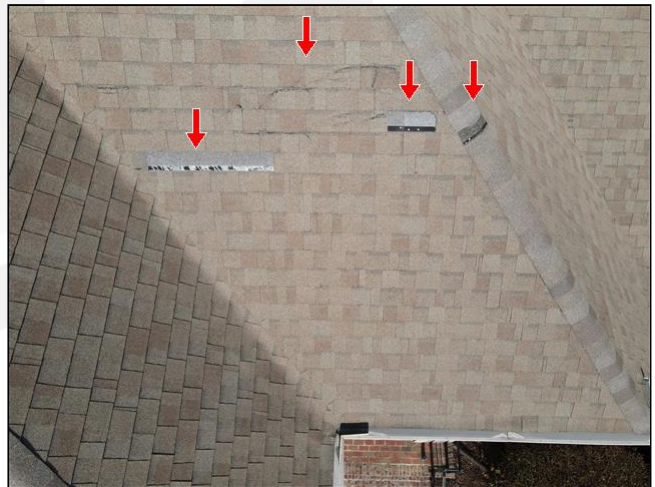
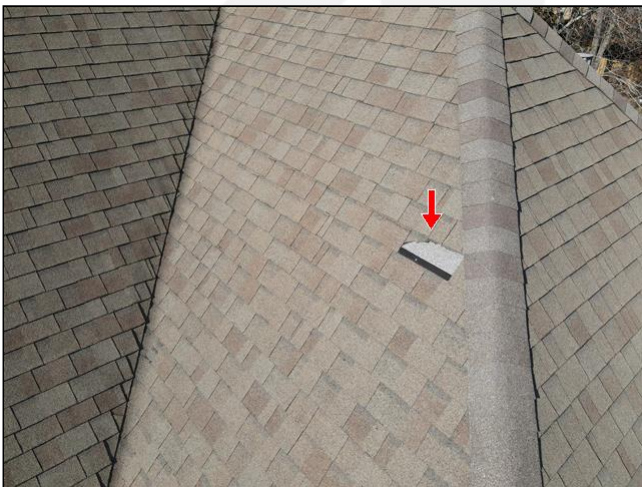
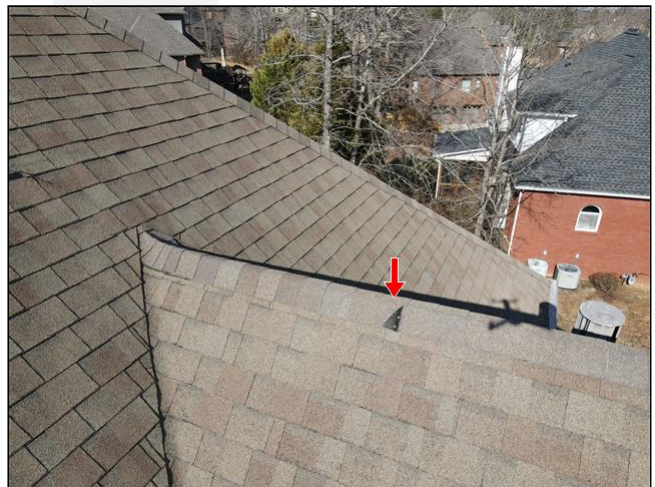
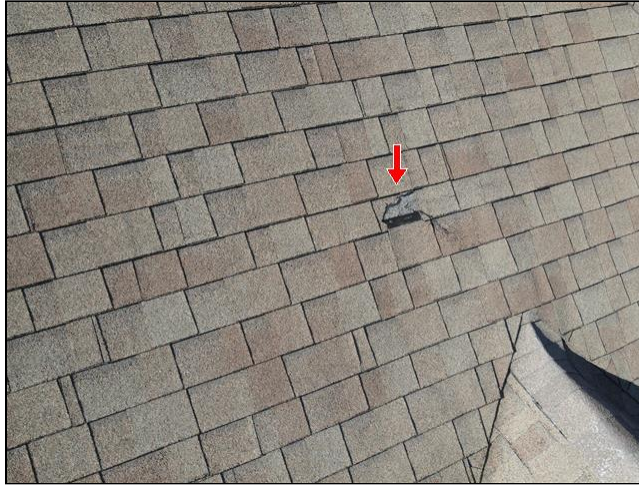
**1.0** The roof covering is old, and the life of the covering has expired. The covering does need to be replaced. While it could last a year or so, some areas need patching due to damaged shingles. Further evaluation is needed to determine the extent of damage and repairs performed as needed to restore functionality.

The roof covering is old, and the life of the covering has expired. The covering does need to be replaced. While it could last a year or so, some areas need patching due to damaged shingles. Further evaluation is needed to determine the extent of damage and repairs performed as needed to restore functionality.

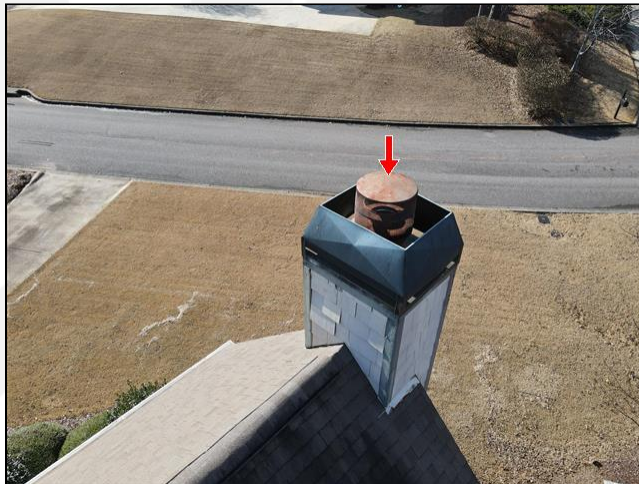
1.2 Item 1(Picture)

**1.2** Although galvanized metal is rust resistant, the natural acidity of rain eventually causes all chimney caps to rust. If no maintenance is performed on a chimney cap it may eventually rust through, causing leaks that could result in damage. With proper maintenance chimney caps can last indefinitely; while both protecting your chimney and remaining largely rust free. The chimney cap was observed to be in need of maintenance as to prevent or slow the rusting process. No area of the cap was observed to be rusted through at time of inspection.

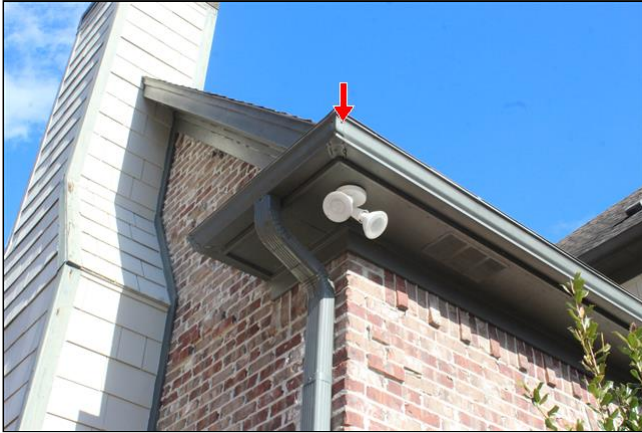
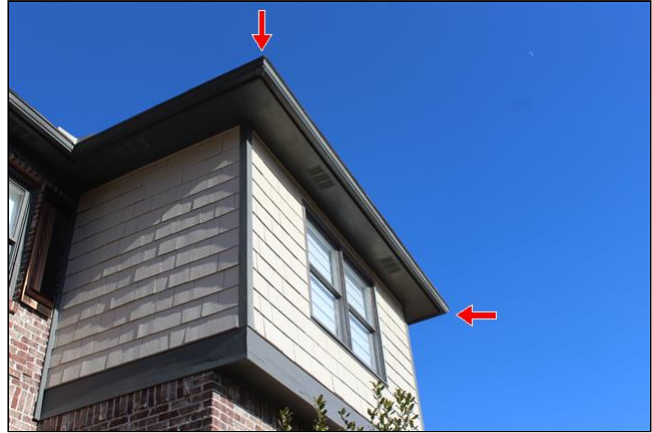
**1.3** The gutter appears to leak at the seam/end cap which will require re-sealing. I recommend cleaning and apply gutter sealant or epoxy.

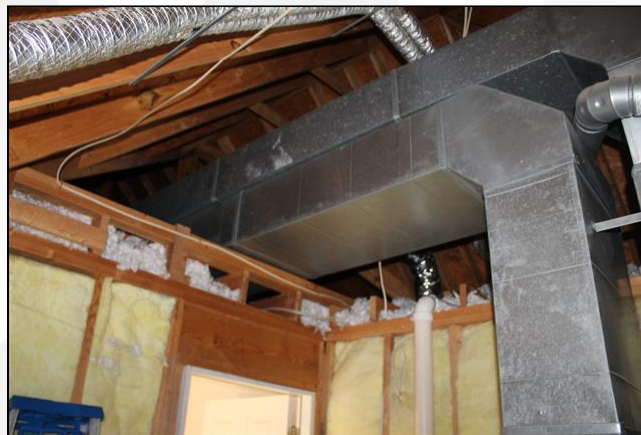
1.4 Item 1(Picture)

**1.4 (1)** The upper portion of the attic space was not accessible at time of inspection as there was no path for access. The walk in attic area does not provide access as the HVAC systems duct work prevents access into the upper portion. Access will need to be installed and further evaluation of this space performed.

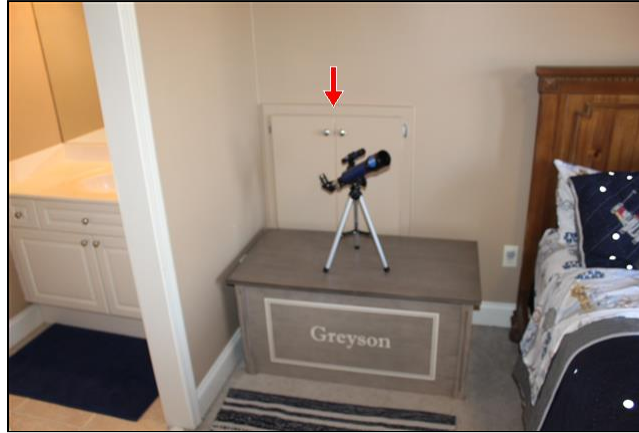
1.4 Item 2(Picture)

**1.4 (2)** The access panel in the wall could not be accessed at time of inspection due to furniture blocking access. Further evaluation of this space should be performed once furniture has been removed.

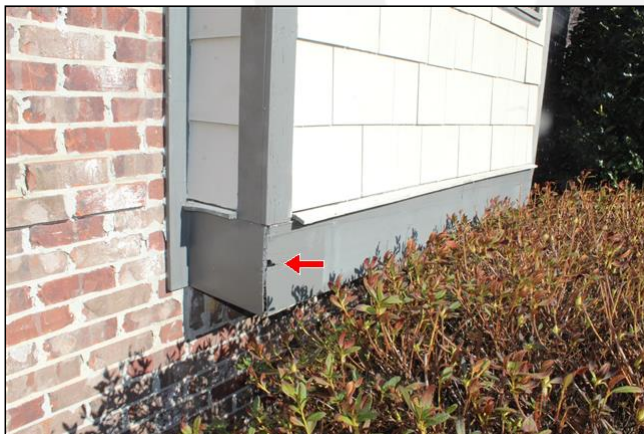
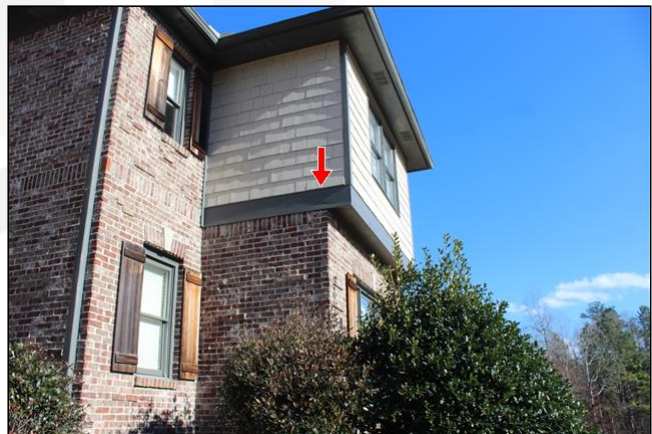
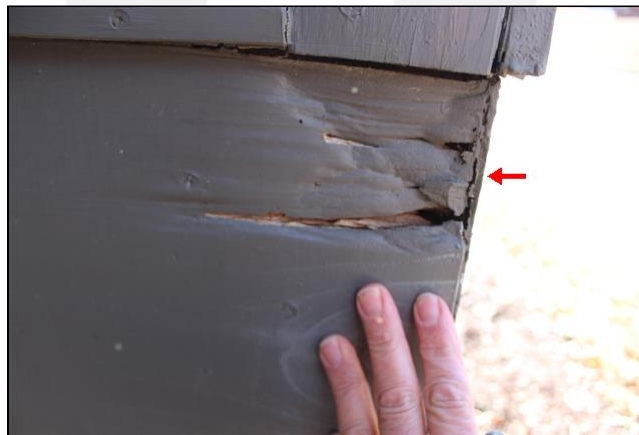
**2.0 (1)** Areas of deteriorated siding will need to be repaired, scrapped to remove loose paint, primed, caulked and painted to prevent further deterioration.

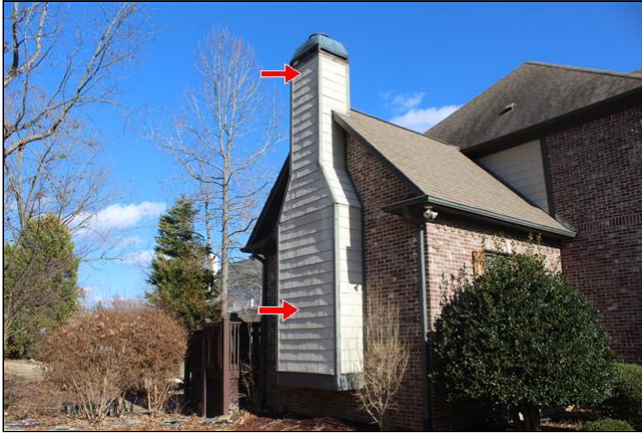
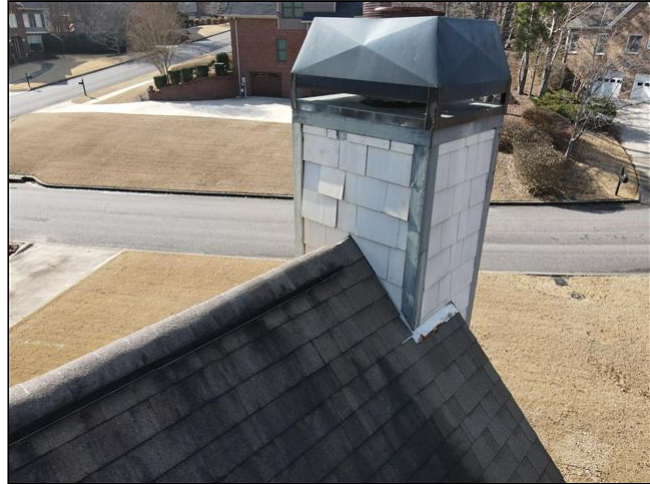
**2.0 (2)** Areas of bare siding / peeling / chalking paint need to be scrapped to remove loose paint, primed, caulked and painted as to restore the intended protection it provides.

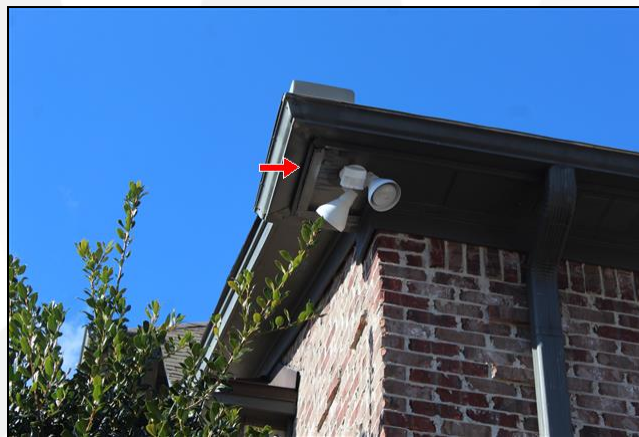
2.1 Item 1(Picture)

**2.1 (1)** Areas of deterioration will need to be repaired, scrapped to remove loose paint, primed, caulked and painted at the exterior to prevent further deterioration.

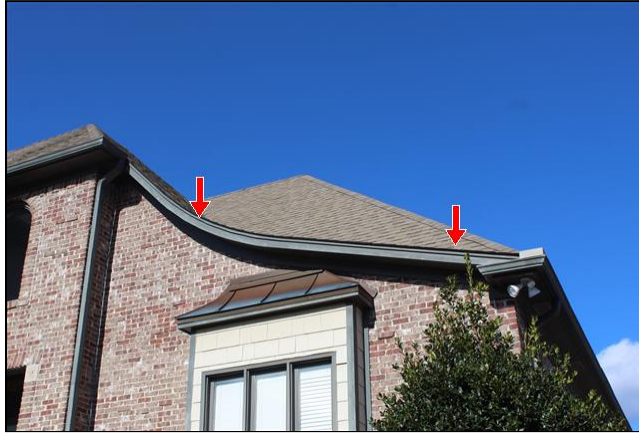
2.1 Item 2(Picture)

2.1 (2) Areas of bare wood / peeling paint need to be scrapped to remove loose paint, primed, caulked and painted at the exterior.

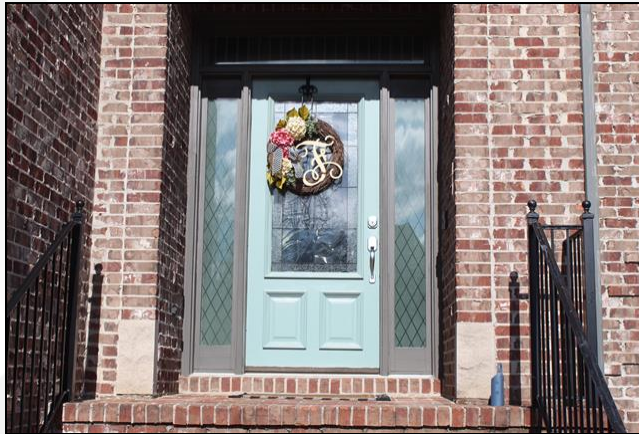
2.2 Item 1(Picture)

2.2 (1) Areas of bare wood / peeling paint need to be scrapped to remove loose paint, primed, caulked and painted at the exterior.

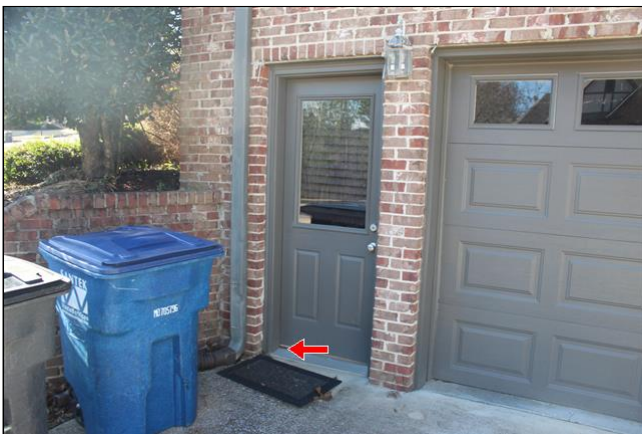
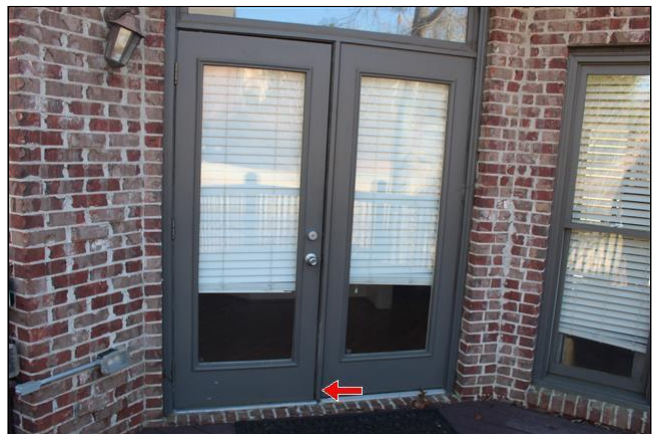
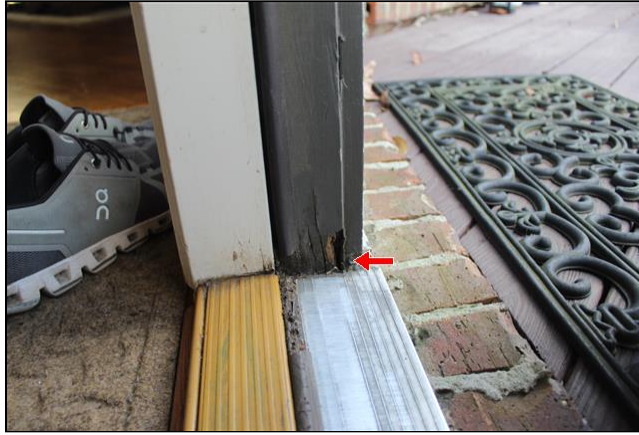
2.2 (2) Areas of deterioration will need to be repaired, scrapped to remove loose paint, primed, caulked and painted at the exterior to prevent further deterioration.

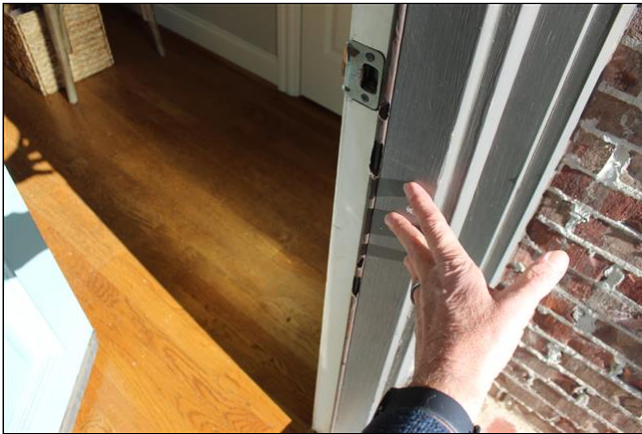
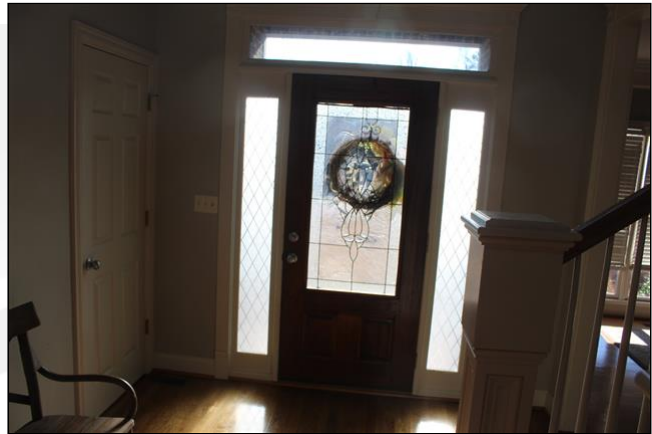
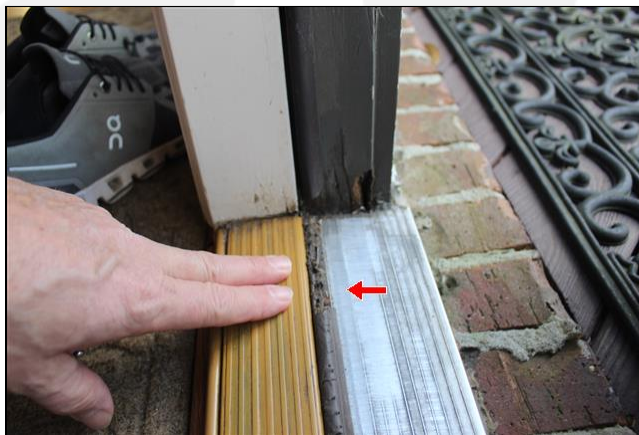
2.2 (3) Damaged weather stripping should be replaced.

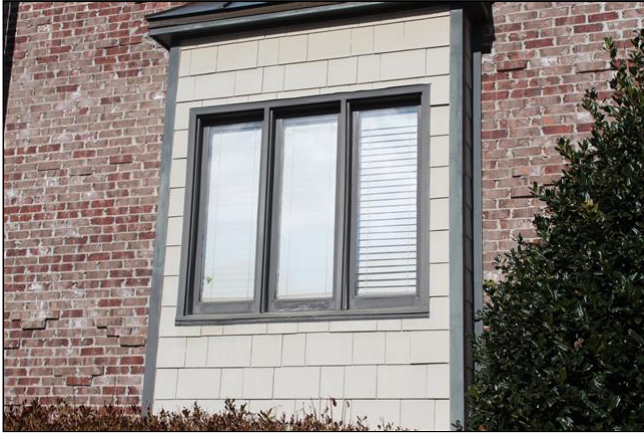
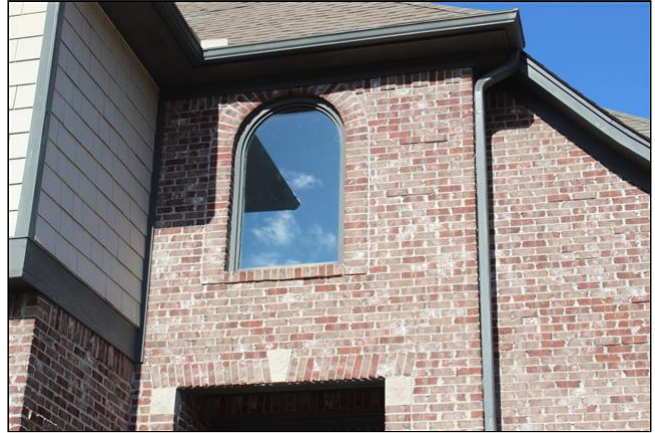
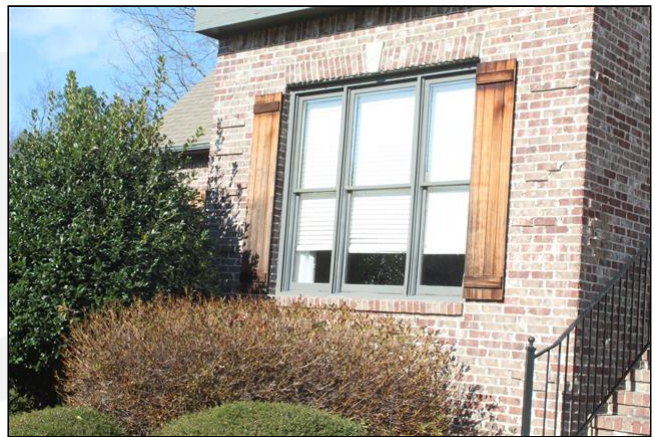
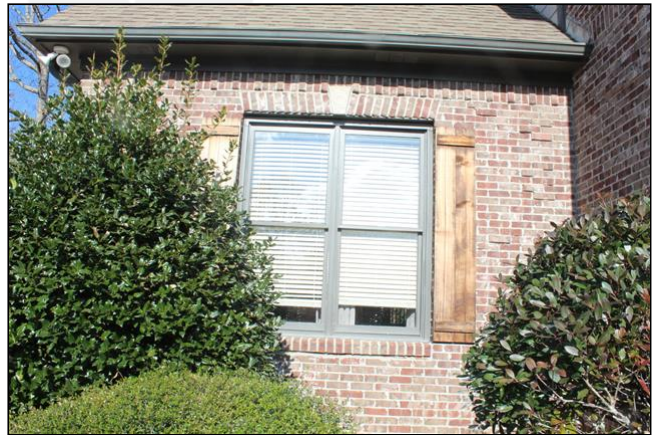
2.3 (1) Areas of bare wood / peeling paint need to be scrapped to remove loose paint, primed, caulked and painted at the exterior.

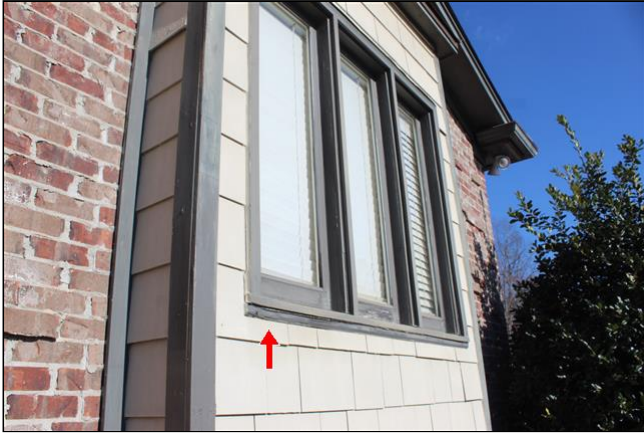
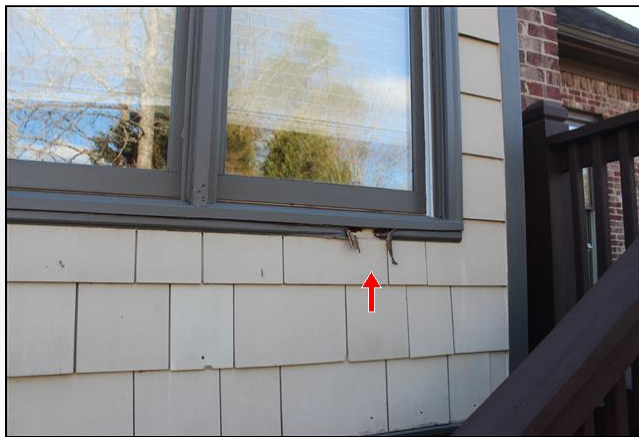
2.3 (2) Areas of deterioration will need to be repaired, scrapped to remove loose paint, primed, caulked and painted at the exterior to prevent further deterioration.

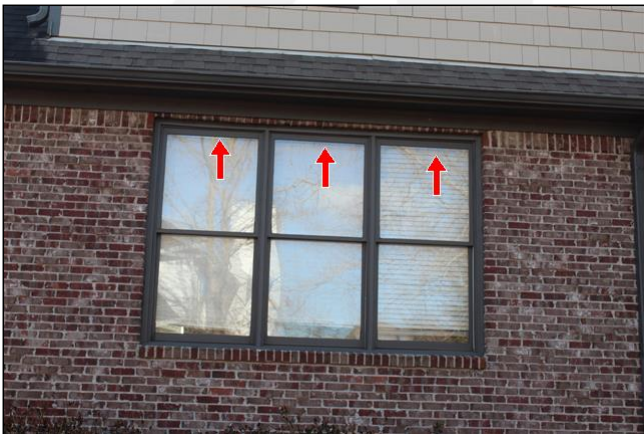
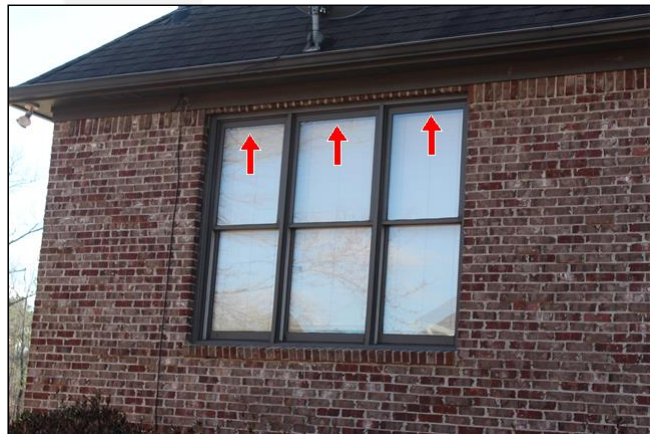
2.3 (3) Observed two windows at rear of home in which a steel lintel was not installed over the window to carry the brick load. While this is only one course of brick the window itself is not designed to carry load at all. Further evaluation is needed and repairs performed as needed to restore functionality.

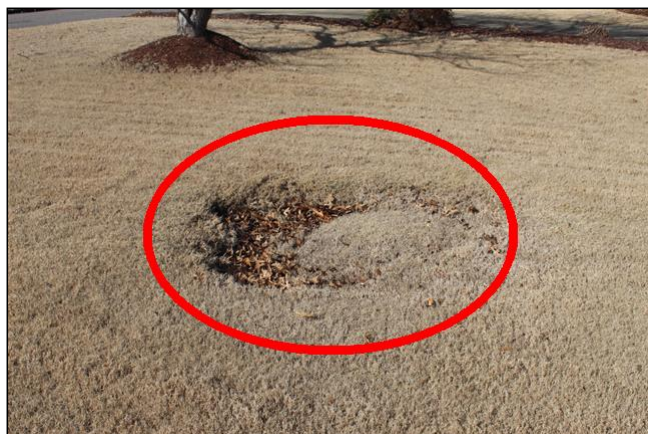
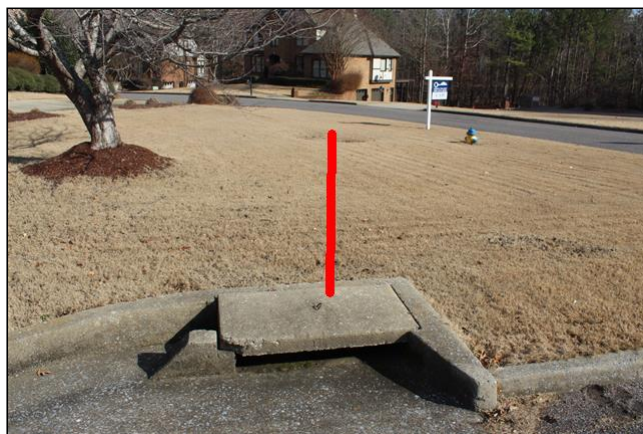
**2.5** A portion of the front yard appeared to be sinking which could be related to storm drainage piping. It appeared that the street drain piping ran under the front yard. Further evaluation is needed to determine the cause and repairs performed as needed to restore functionality.

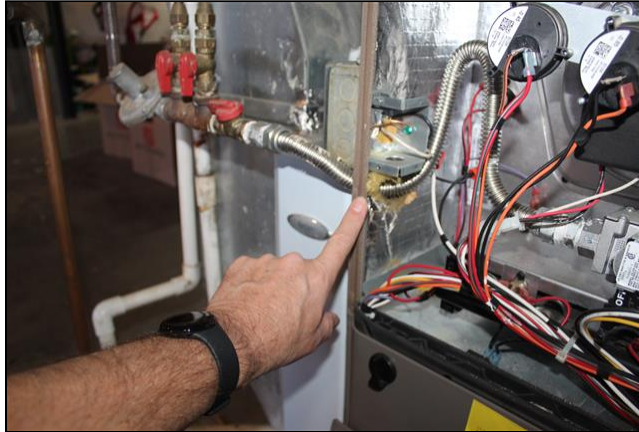
4.0 Item 1(Picture)

**4.0** Observed CCST gas piping used at the furnace. Where CSST piping passes through the housing of an appliance, it must be protected from physical damage which was not present at time of inspection. Corrections are needed for proper installation and fire safety.

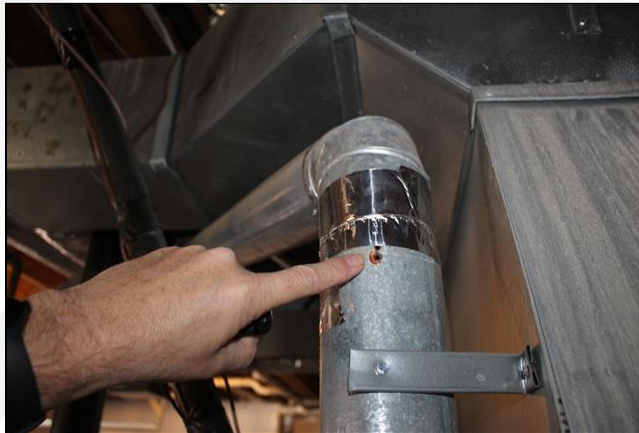
4.5 Item 1(Picture)

**4.5** The flue pipe in the garage was observed to have two open holes which should be sealed off for safety.

The flue pipe in the garage was observed to have two open holes which should be sealed off for safety.

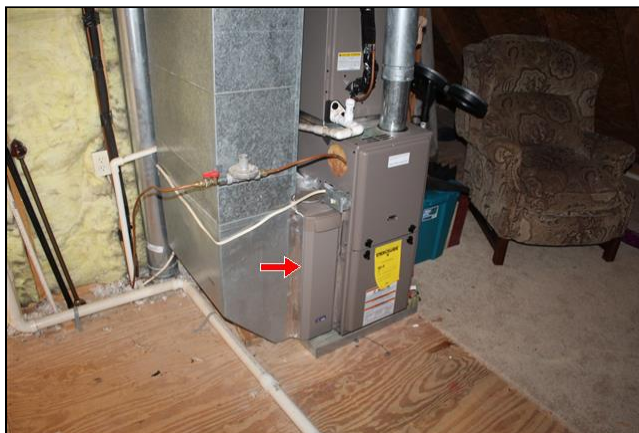
4.6 Item 1(Picture)

**4.6 (1)** The filter is located at the unit in the attic.

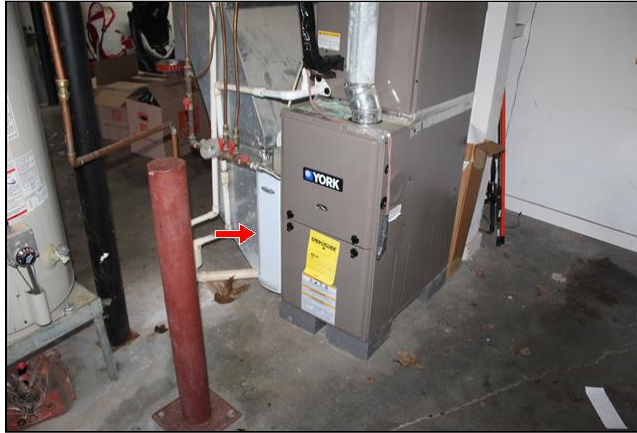
4.6 Item 2(Picture)

4.6 (2) The filter is located at the unit in the garage.

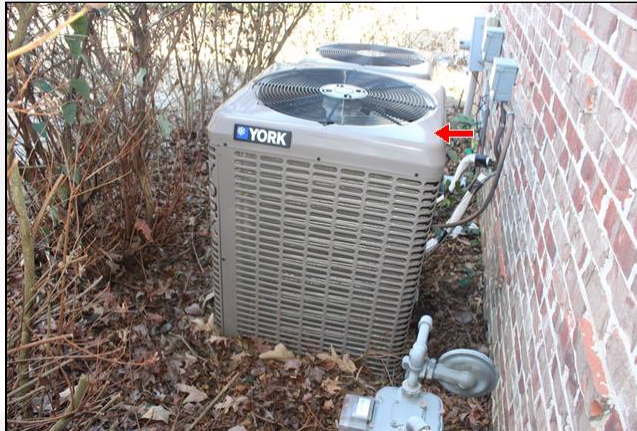
4.7 Item 1(Picture)

4.7 (1) The platform for the HVAC compressor outside has settled which should be leveled. It is important to keep your outdoor AC condenser unit level for optimal performance and longevity.

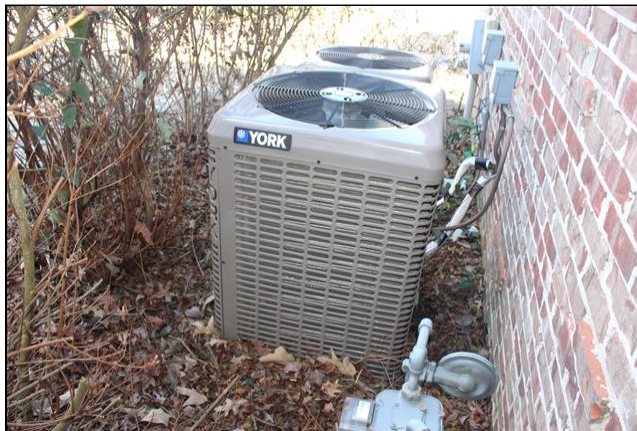
4.7 Item 2(Picture)

4.7 (2) Due to outside temperatures below 65 degrees at time of inspection we were unable to test the cooling system(s) of the home. A visual inspection only was performed on the cooling system.

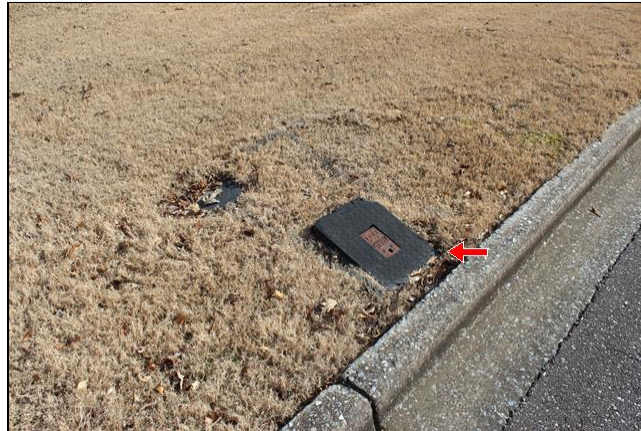
5.0 Item 1(Picture)

5.0 The main shut off is located outside in the ground at the water meter. Also there is a main shut off in the garage where the main water line enters the home.

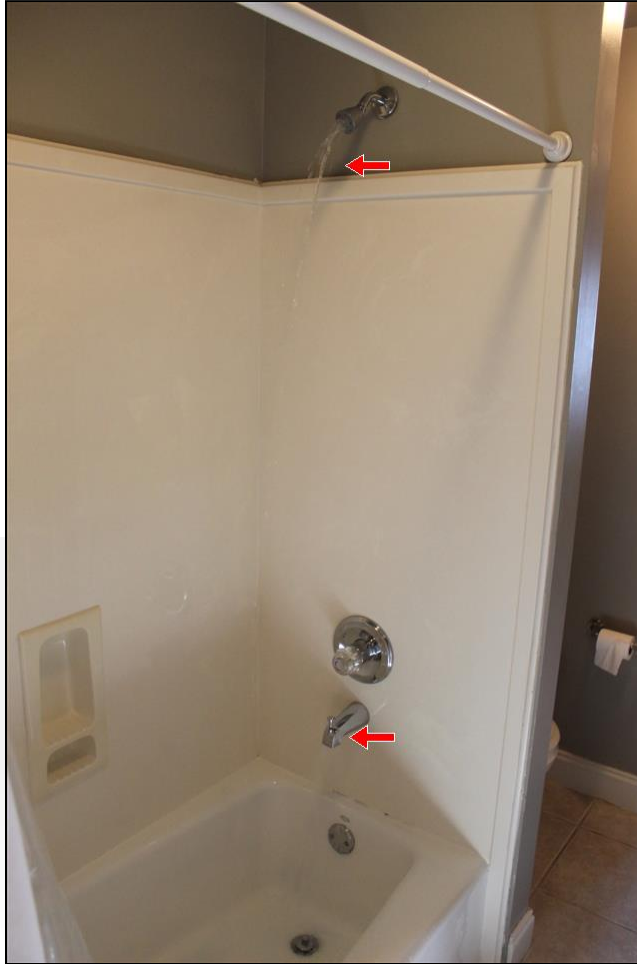
5.2 Item 1(Picture)

**5.2 (1)** The passthrough bath shower lever would not fully engage so water pressure at the shower head was very poor. The plate that closes off the spigot likely needs to be cleaned so it can completely engage.

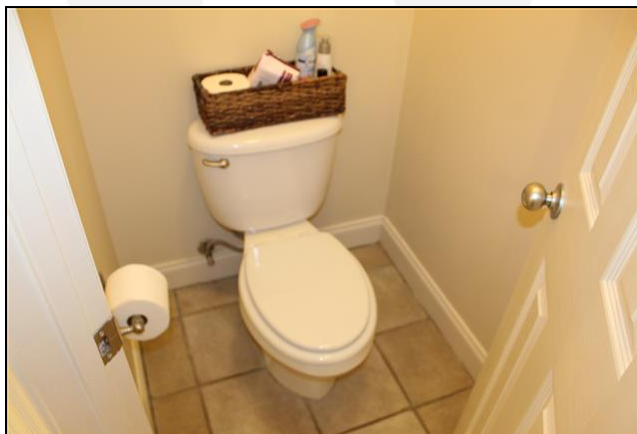
5.2 Item 2(Picture)

**5.2 (2)** The toilet was loose at the Primary Bath which will need to be secured. Repairs may involve re-setting the toilet on a new wax seal.

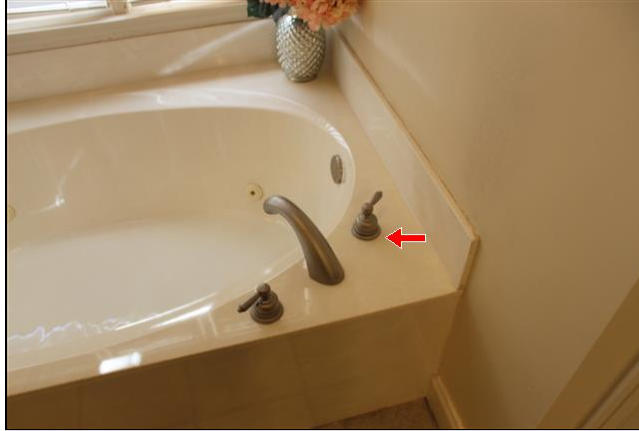
5.2 Item 3(Picture)

5.2 (3) The primary bath tub fixture was observed to leak from around the handle when tested indicating a failed seal.

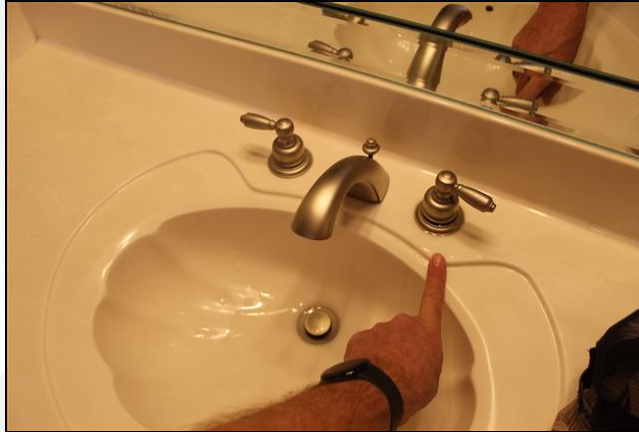
5.2 Item 4(Picture)

5.2 (4) The primary bath sink fixture was observed to leak from around the handle when tested indicating a failed seal.

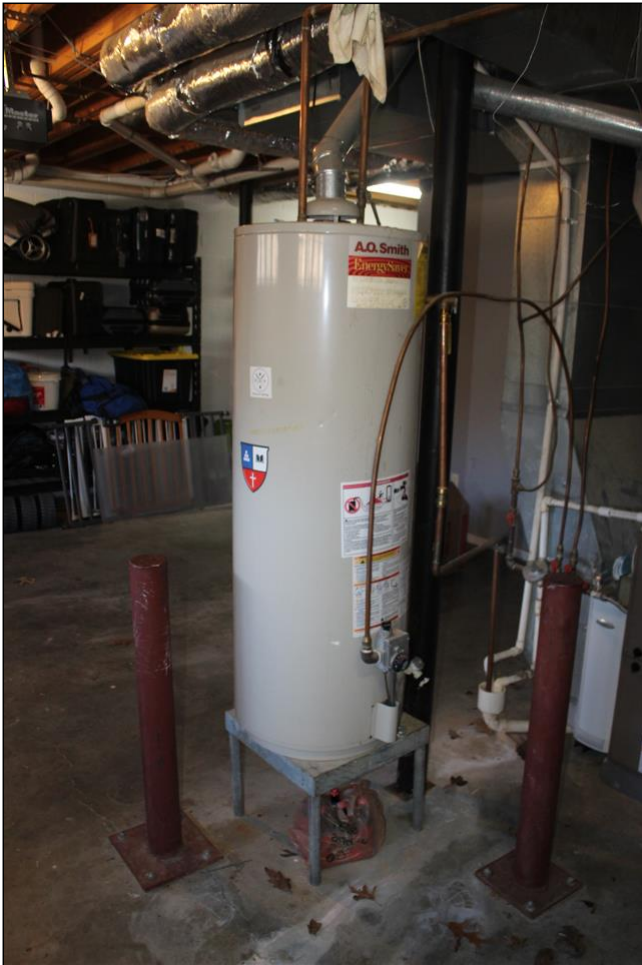
5.3 Item 1(Picture)

**5.3** Water heaters have an average life span of 8 to 12 years. This is an average and not a guarantee. With good maintenance practices, appliances can last well beyond the average. Neglected, they may fail early. While this unit was operating normally at time of inspection, this unit is well past the average life span of water heaters.

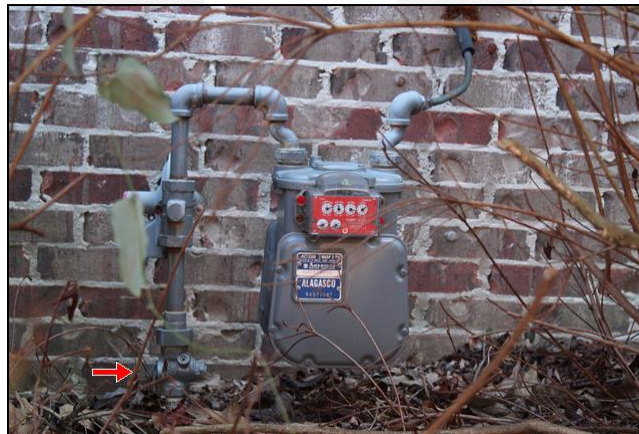
5.4 Item 1(Picture)

**5.4** The main fuel shut off is at the gas meter outside.

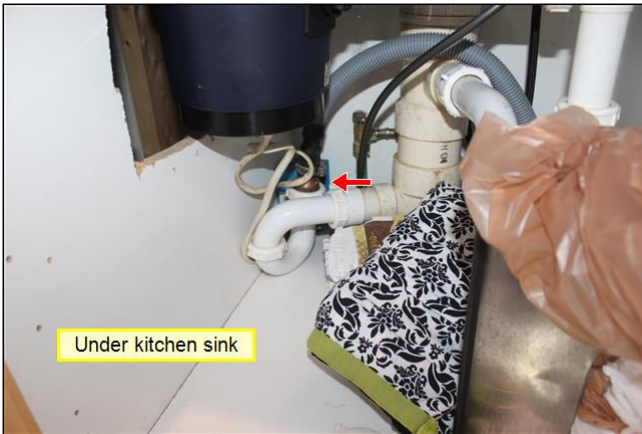
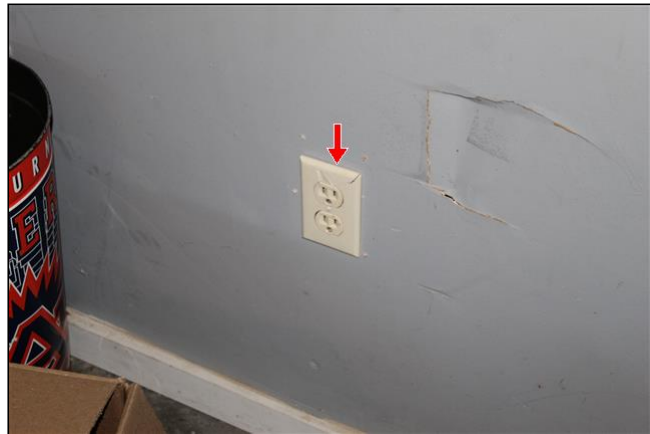
**6.3** Damaged or missing outlet / junction covers will need to be replaced.

Under kitchen sink

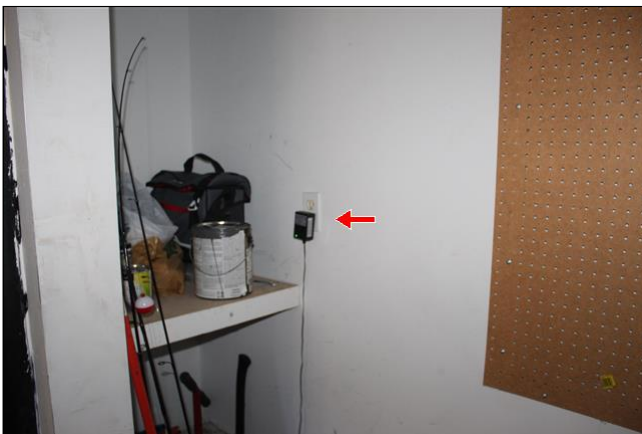
6.4 Item 1(Picture)

**6.4** One or more GFCI (Ground Fault Circuit Interrupter) receptacles did not trip/reset when tested (defective/missing) which should be corrected for electrical safety.

1. Garage

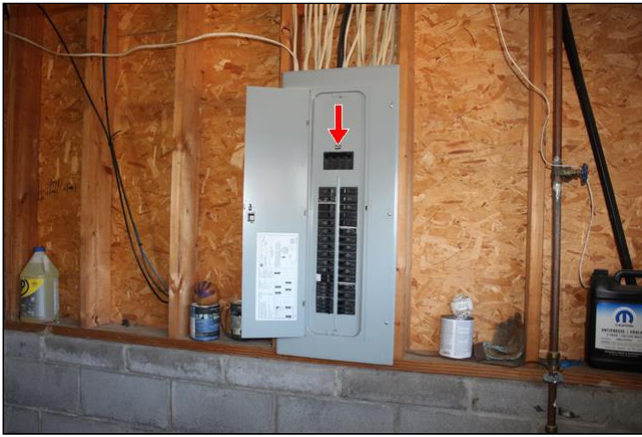
6.6 Item 1(Picture)

6.6 The main service disconnect is located in the panel at the garage.

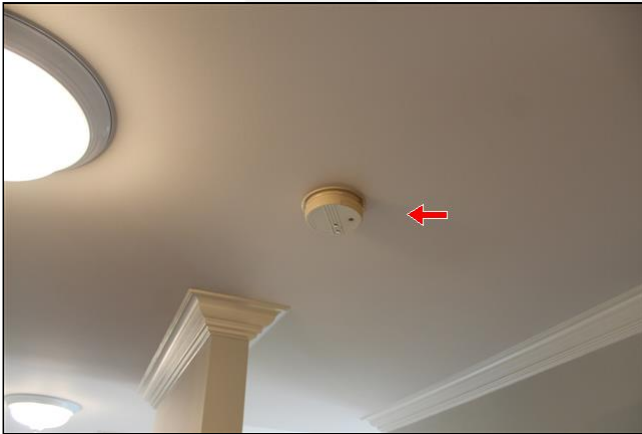
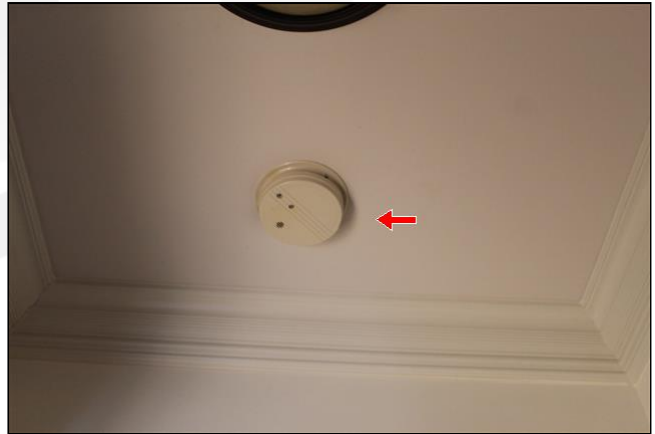
6.7 (1) Smoke alarms have a limited lifespan. The National Fire Protection Association (NFPA) recommends every smoke alarm be replaced after 10 years and that regular batteries be replaced every six months. Due to the age of the installed Smoke/Heat Alarms, the alarms should be replaced for increased fire safety.

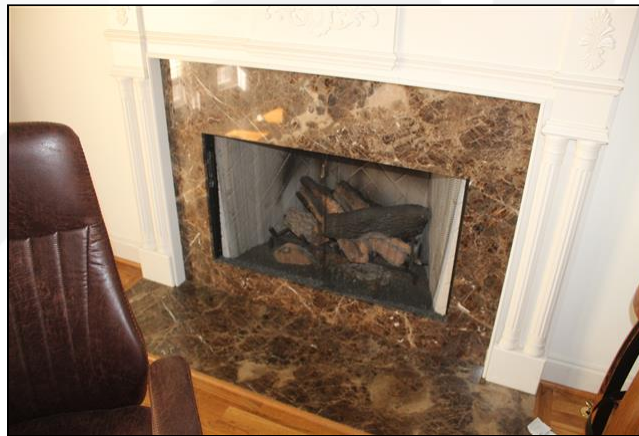
7.0 Item 1(Picture)

**7.0** Vented gas logs sets are extremely safe when properly operated. You should familiarize yourself with the proper operation of the log set installed by reviewing the manufacturers operators manual. Inspector recommends that Carbon Monoxide Alarms be installed according to current safety specifications.

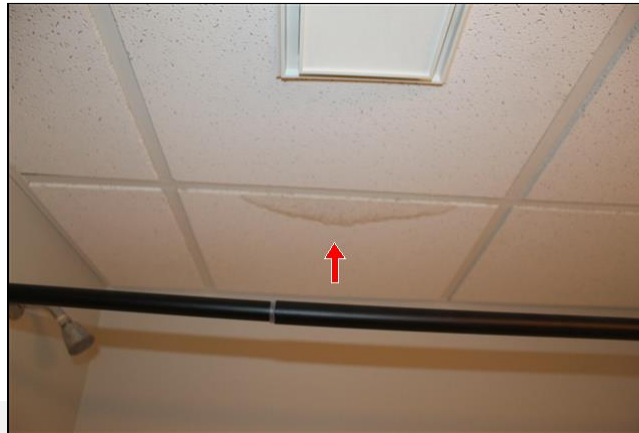
8.0 Item 1(Picture)

**8.0** Observed previous water stains at the interior ceiling(s), however this area was confirmed dry using a moisture meter at time of inspection.

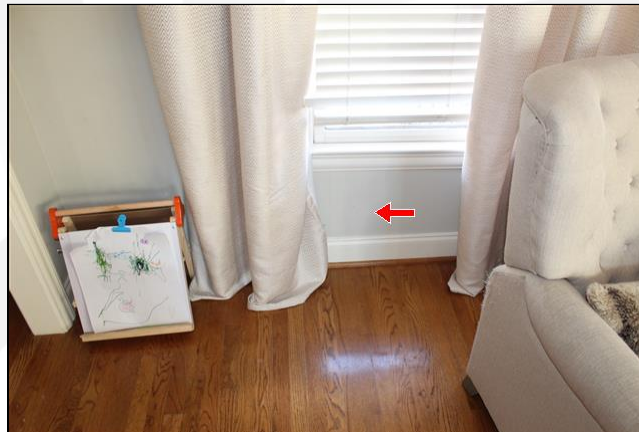
8.1 Item 1(Picture)

**8.1** Observed hairline cracks at the interior sheetrock wall(s), however did not observe any indications of concern associated with these cracks. A qualified person should prep, prime, paint as desired.

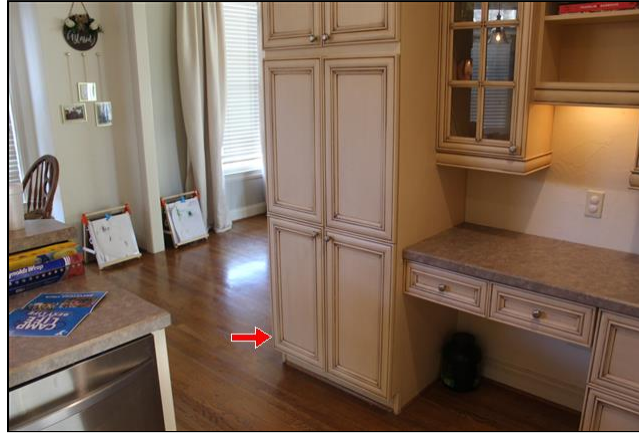
8.4 Item 1(Picture)

**8.4** One or more interior cabinet doors needs hinge adjustments as to shut properly. This is a maintenance issue and is for your information.

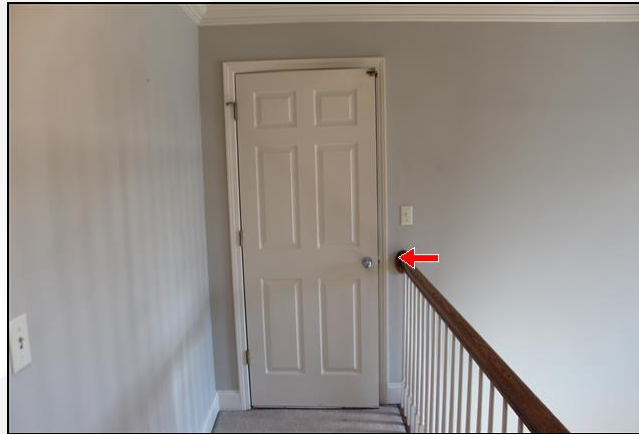
8.5 Item 1(Picture)

**8.5** One or more interior doors needs strike/latch/hinge adjustments or missing hardware installed as to shut/latch properly. This is a maintenance issue and is for your information.

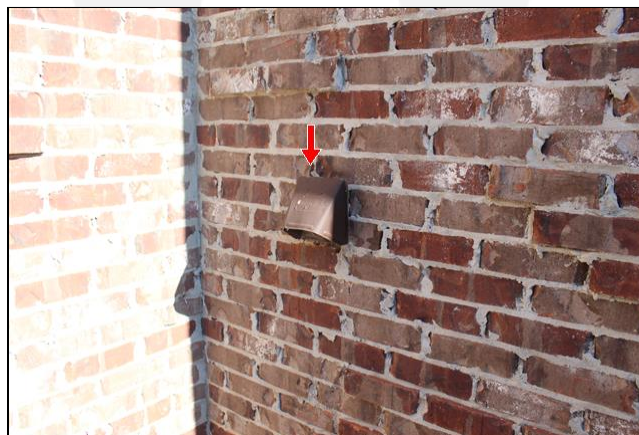
9.3 Item 1(Picture)

**9.3 (1)** Exterior vent hood should be sealed to wall with a clear sealant at the top and sides to prevent water entry.

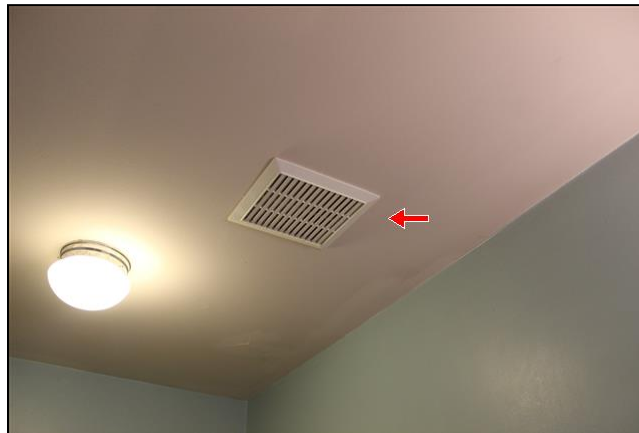
9.3 Item 2(Picture)

**9.3 (2)** The private bathroom ventilation fan was not operational at time of inspection, a new unit will likely need to be installed to repair.

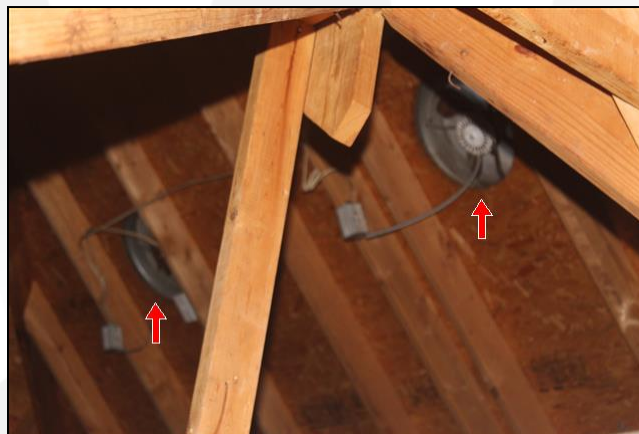
9.4 Item 1(Picture)

**9.4** The attic ventilation fan were not able to be tested due to lack of proper access into the upper attic area. These units should be tested for operation once access is achieved.

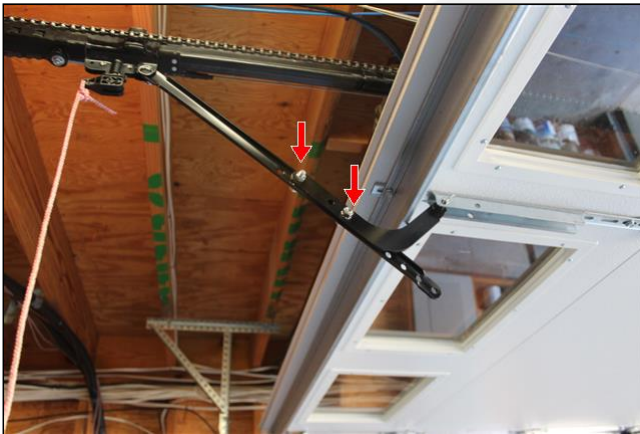
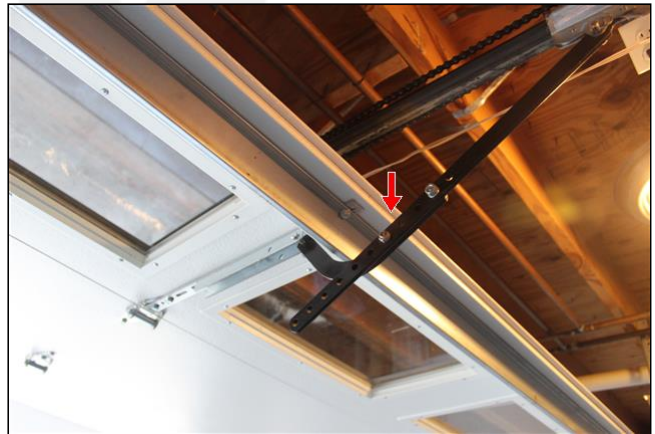
**10.2** Loose hardware at the garage doors will need to be secured.
